PROTECTION MEASURES FOR TAMILNADU COAST

Final Report

PUBLIC WORKS DEPARTMENT
GOVERNMENT OF TAMILNADU

Prof. V. SUNDAR
&
Prof. R. SUNDARAVADIVELU

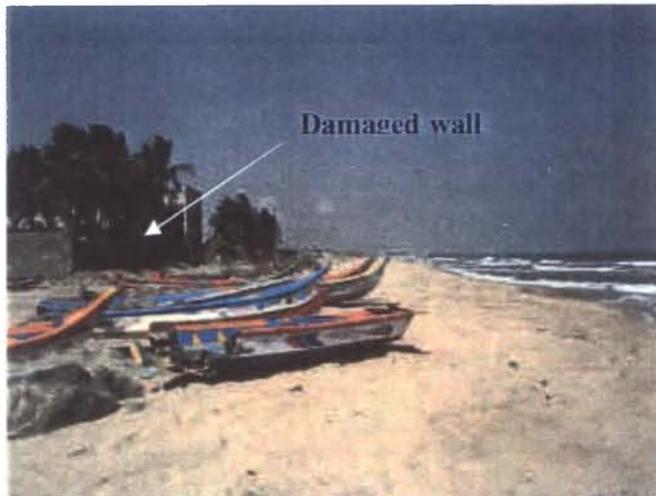
A number of dwelling units adjacent to the coast has been washed away due to tsunami and leveling of ground and debris is in progress as can be seen in photo.2.18. This village is north of Palar River. The Palar river traps some of the sediment transport directed towards North leading to a deficit of sediment supply, thus, leading to erosion along this stretch of the coast. A compound wall of CISF quarters in this village suffered damage, which is being rectified as can be seen in photo. 2.19. Oyyalikuppam needs to be protected by groin field with an average length of about 200m for a stretch of 2 km as shown in fig. 2.11.

Photo 2.18. Leveling of the ground and clearing of debris in progress in Oyyalikuppam

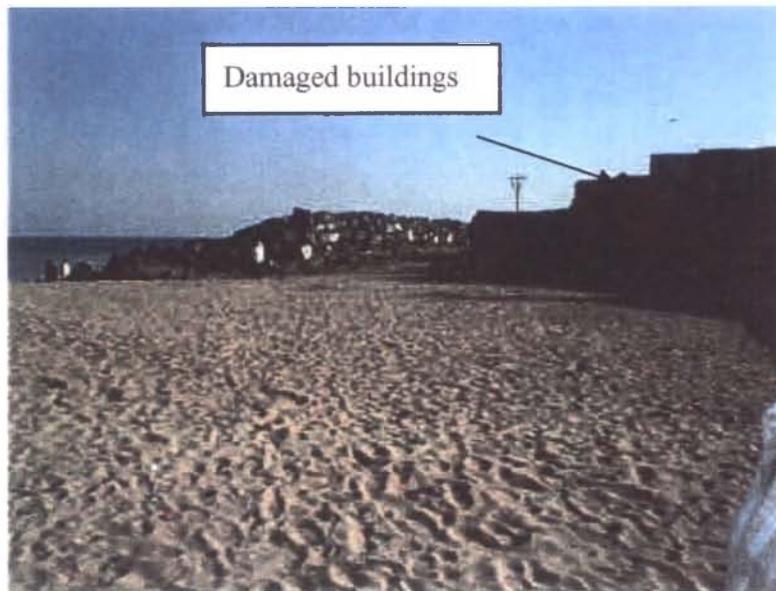
Photo 2.24. Damaged buildings due to tsunami in Sodanaikuppam

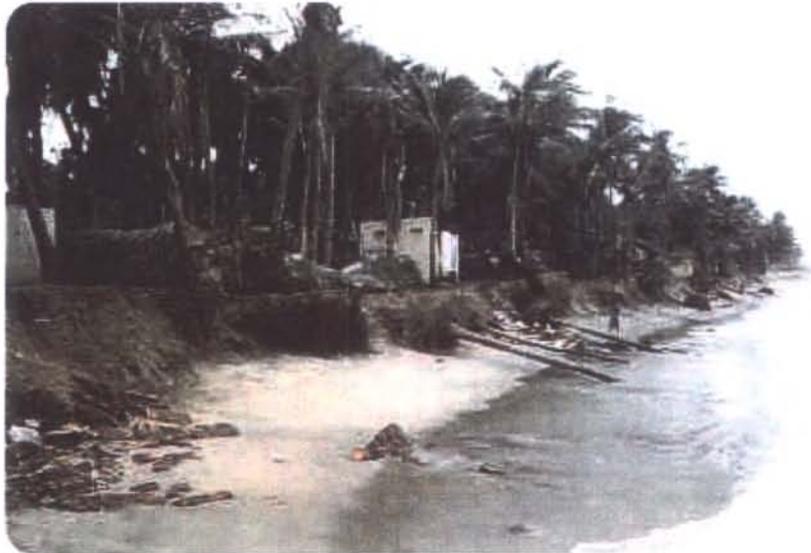
Photo 2.25. View of coastal erosion at Rahamathnagar

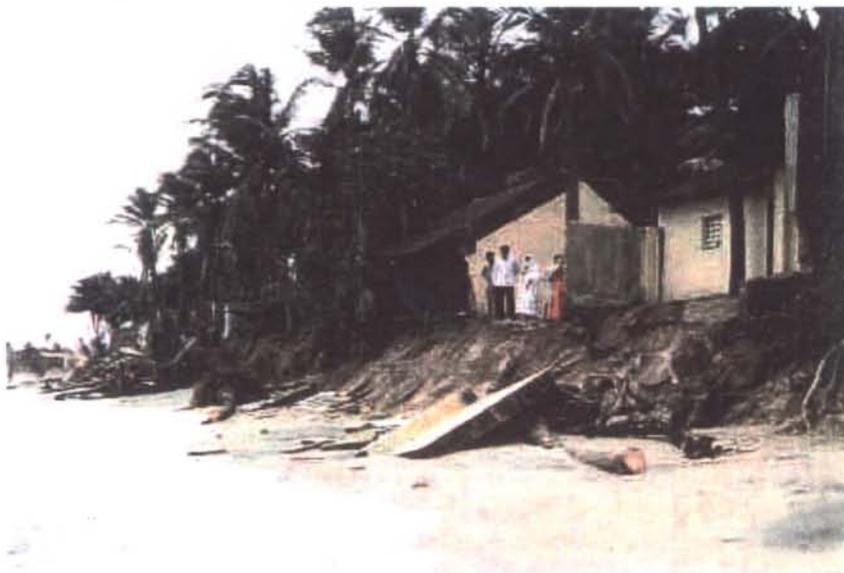
Photo 2.26. Damaged buildings due to coastal erosion at Rahamathnagar

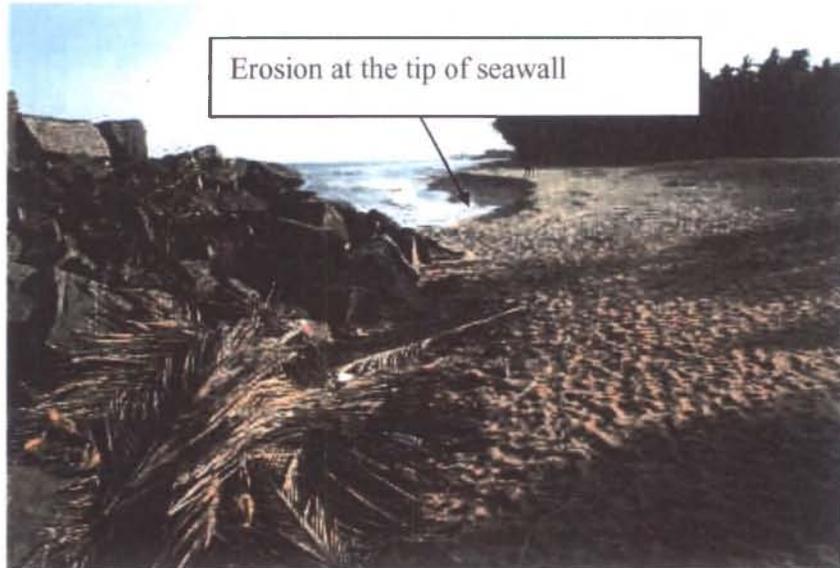
Photo 2.27. Erosion near the seawall at Nadukuppam

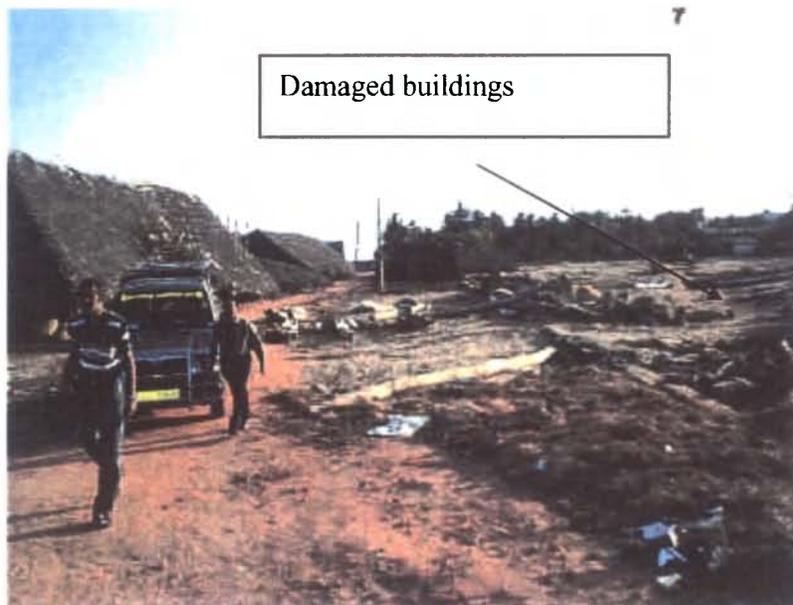
The damages near this village are shown in photo.2.28. From this village, a stretch of about 3.5km north of this village (Muthialpet, Mudaliarchavadi, Bommayapalyam) is densely populated and hence need to be protected with a groin field (fig.2.15). The groin field will consist of 9 groins with an average length of 150m. Sandy beaches are also available at a few pockets, where, plantations can be done as a long-term measure for the protection of the coast. The width of the beach from Muttukaadu Azhagankuppam to Mudaliar Chavadi in Villupuram district after the tsunami is provided in Table. 2.1.

Photo 2.28. Damaged buildings due to tsunami in Thandriyankuppam

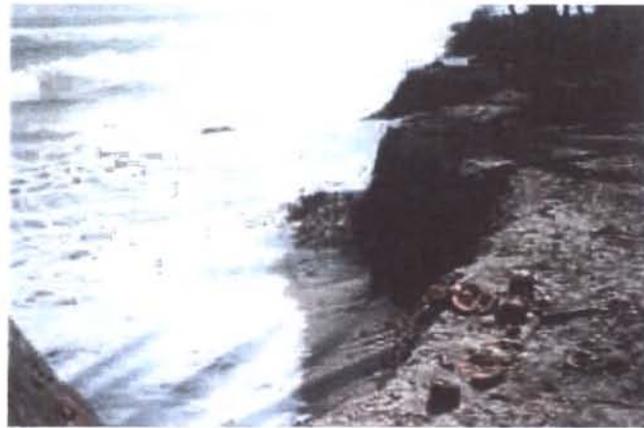
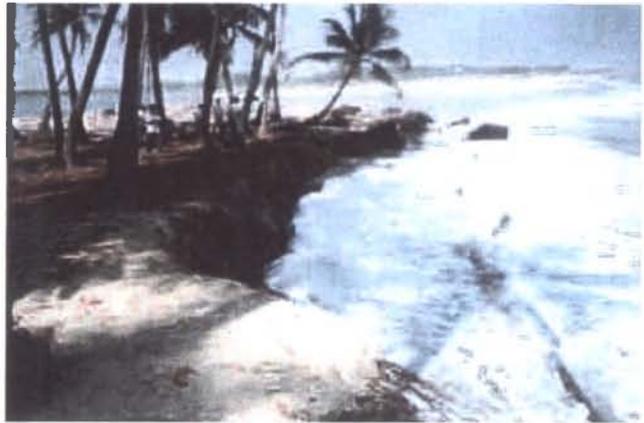
Photo 2.34 a & b . A view of damaged coconut trees at Thazhanguda due to tsunami

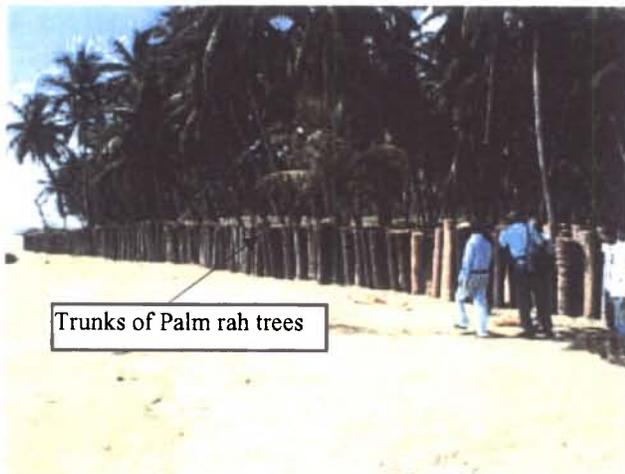
Photo 2.35 Temporary shore protection measure being adopted by PWD

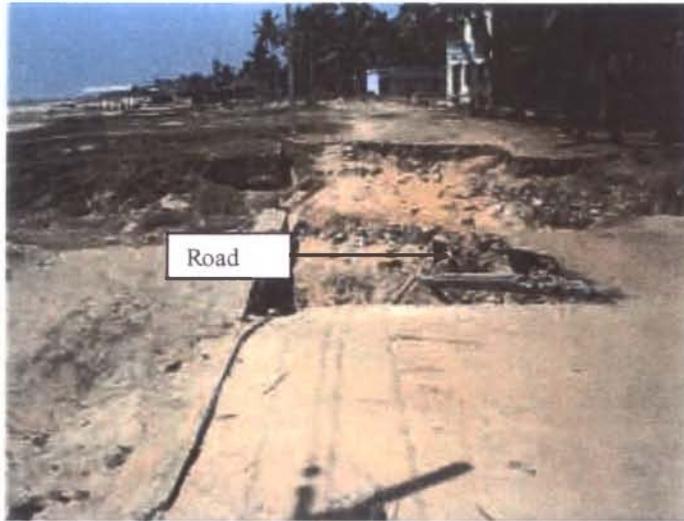
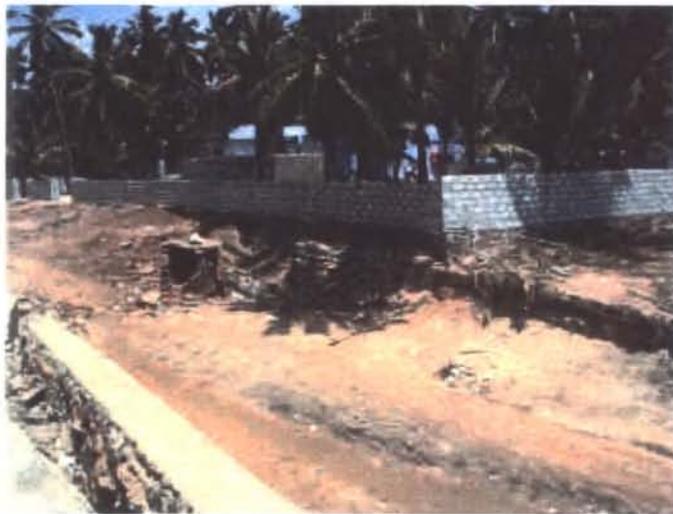
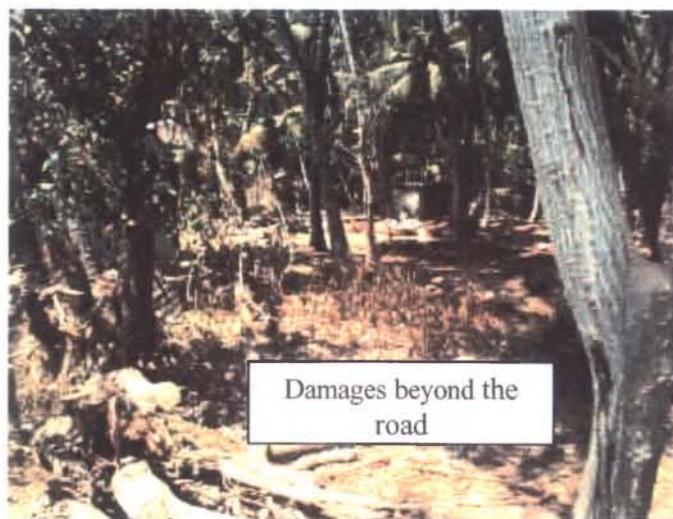
Photo 3.11, 3.12 & 3.13 Views of the damage caused due to penetration of tsunami

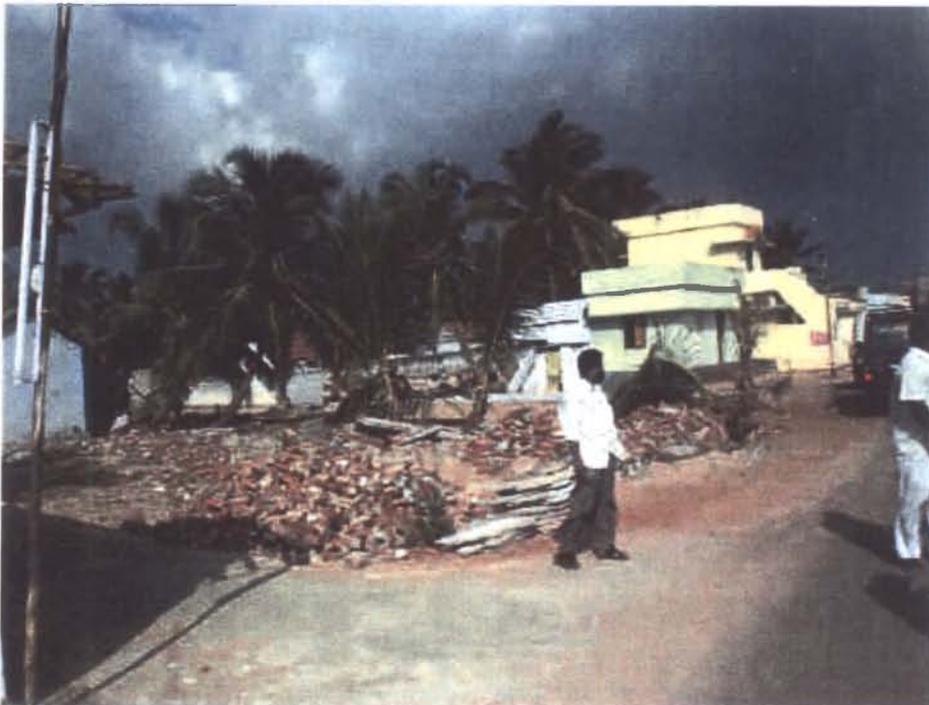
Damages to the houses land ward side of the shore is shown in photo 3.19. The beach which is formed, where the catamarans are parked as can be seen in photo 3.20, is of

Photo 3.19 The damaged houses due to tsunami at Pallanthurai

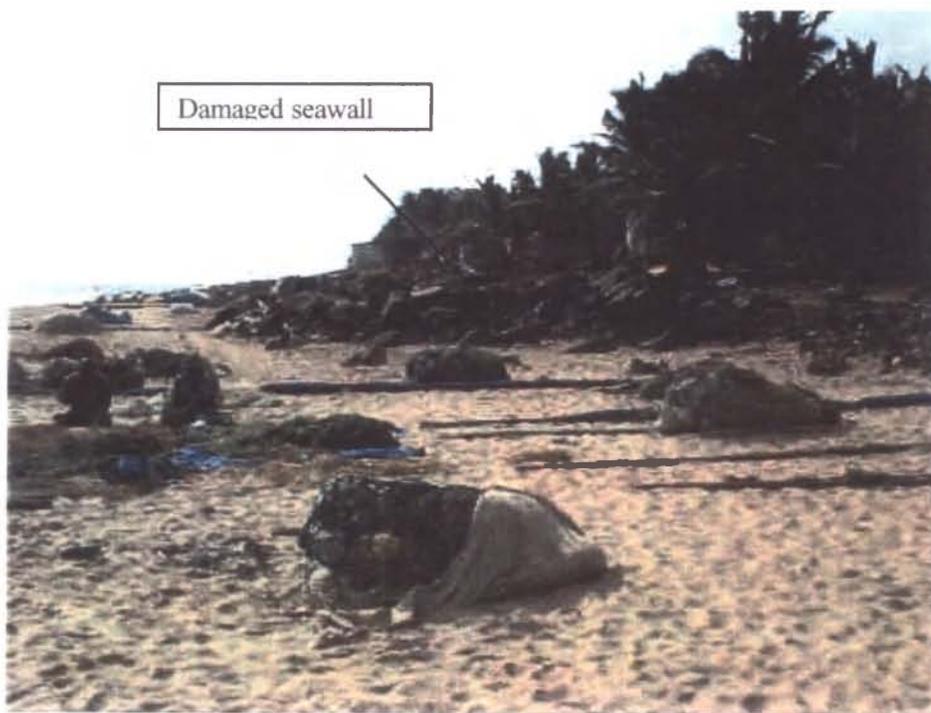
temporary nature, as it gets eroded during the monsoon months. It is found that the land is at a lower elevation. The damage to the existing seawall is shown in **photo 3.21**. It is recommended to raise the crest elevation of the seawall by 2.0 m. Further, two groins are recommended. The average length of the groins will be about 300 m which is included in the above figure. These two groins will act as protective measure only for the Pallanthurai stretch against erosion. Also, it is recommended to immediately stop the sand quarrying at this stretch.

Photo 3.21 The damaged existing seawall at Pallanthurai

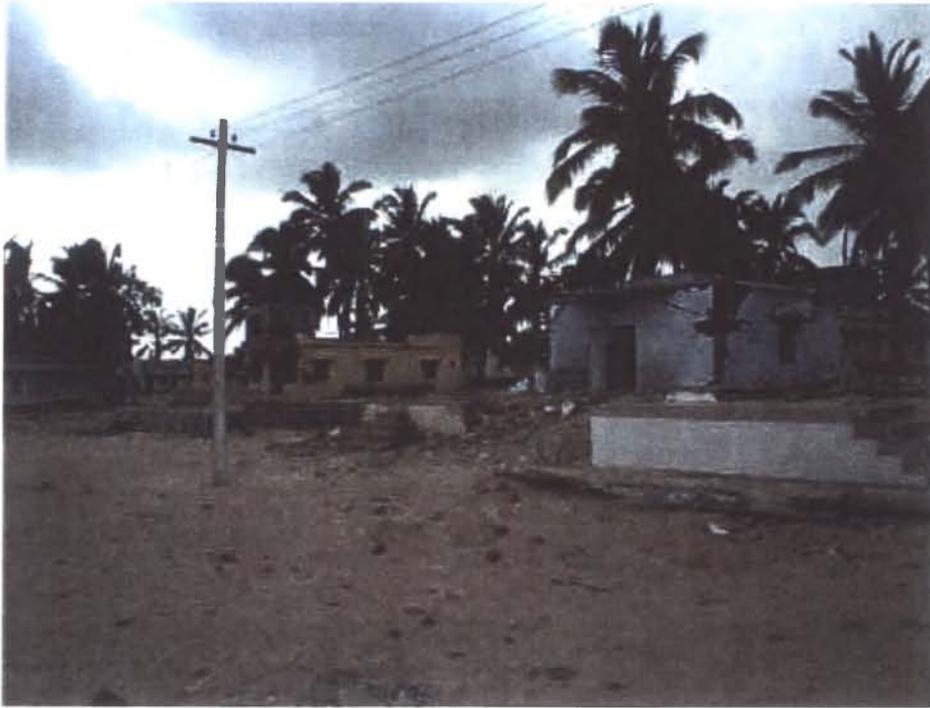
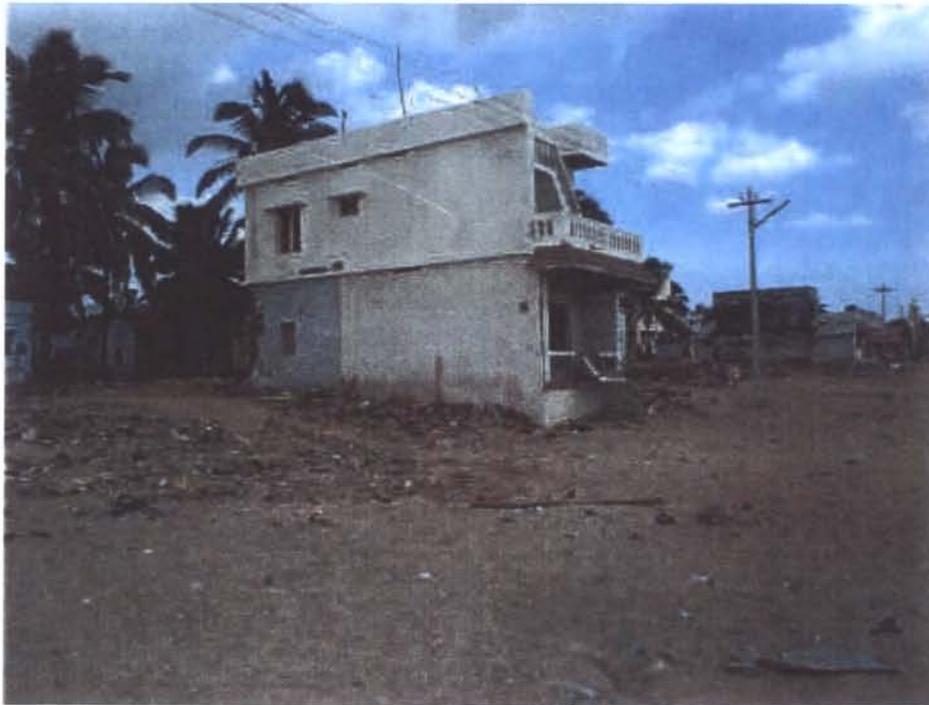
The sufficient beach width along this stretch of the coast is as shown in **photo 3.22 a & b**. Hence, plantations are recommended for this stretch for upto a distance of 2 Km. The damaged buildings due to tsunami in Mezhamanakudithurai is shown in **photos 3.23 a & b**.

**Photo 3.23 a & b View of the damaged houses due to at
Mezhamanakudithurai**

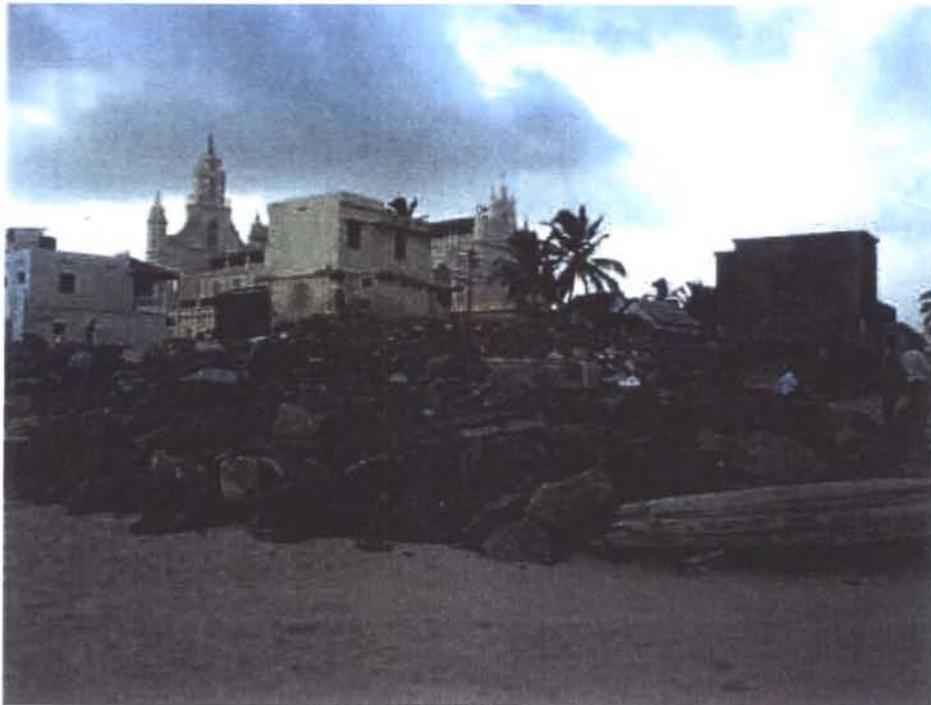
Photo 3.27. Damages on the leeside of the seawall

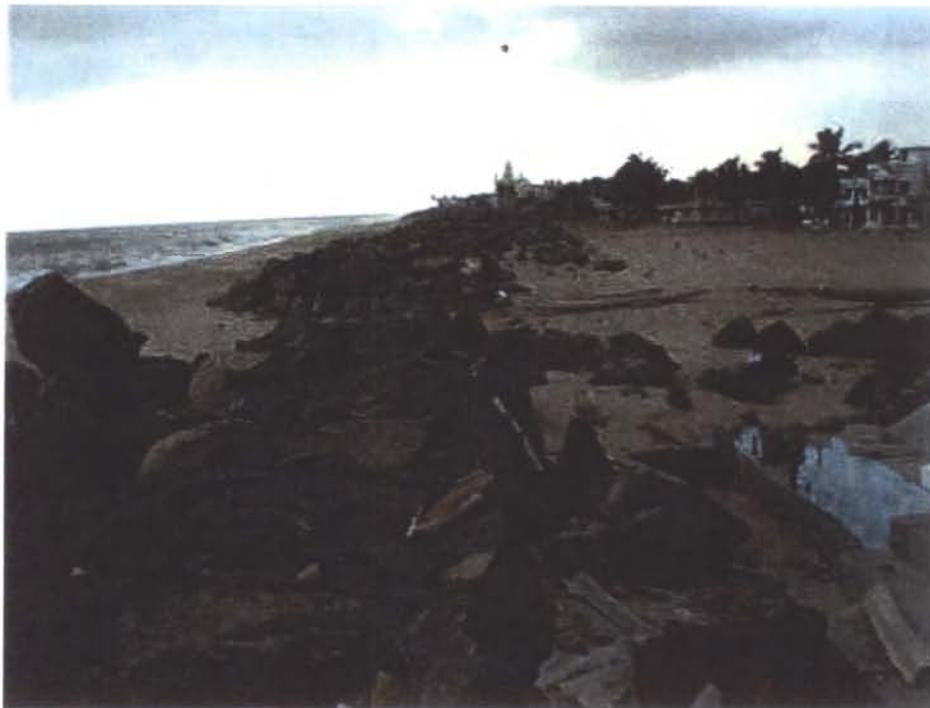
This village is located on the Eastern side of the river Palayar. The existing seawall completely disturbed is shown in **photo 3.28**. A number of dwelling units and churches got damaged as shown in **photo 3.29**. Hence, a groin field for upto distance of 1.5 Km is recommended. Further, it is also recommended to raise the crest elevation of the existing seawall by 2.0 m. The complete scheme of protection measure for these villages,

Photo 3.28. The damaged existing seawall at Keezhamanakudithurai

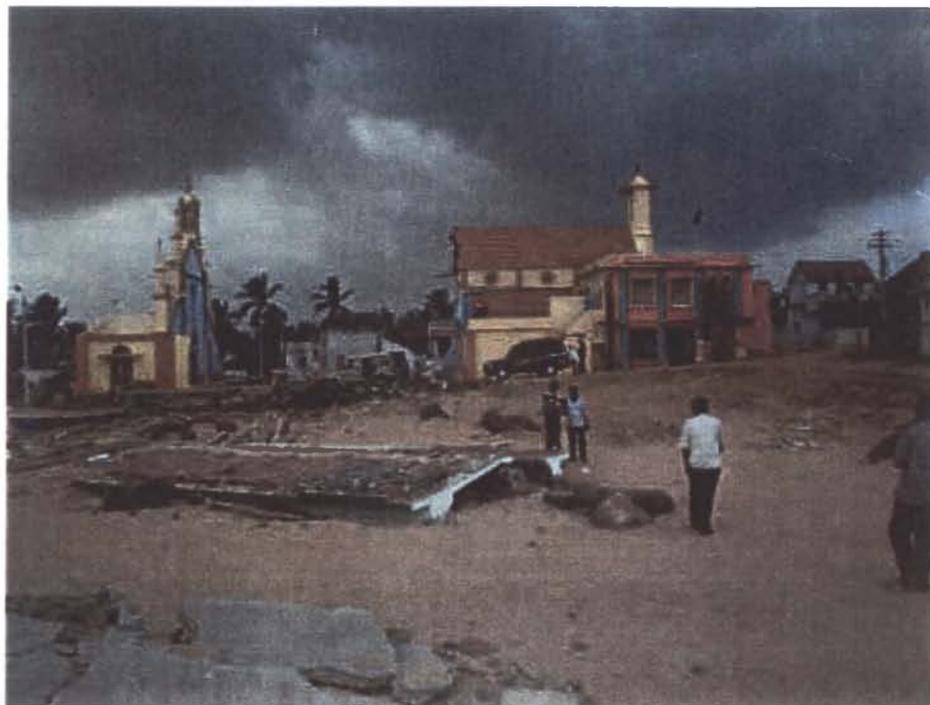
Photo 3.29. The damaged church and dwelling units

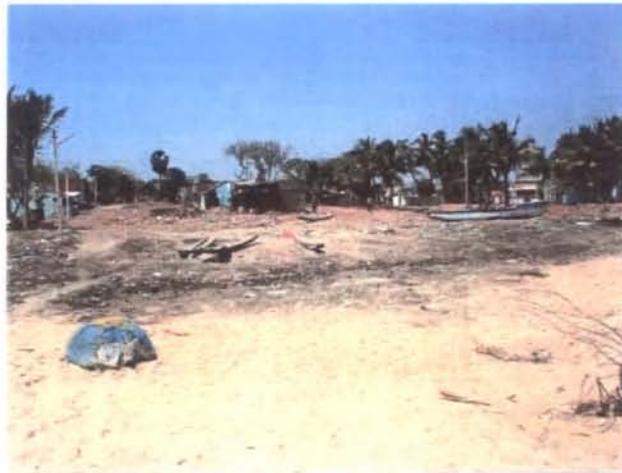
Photo 4.1 Damages to the property at Nagoor

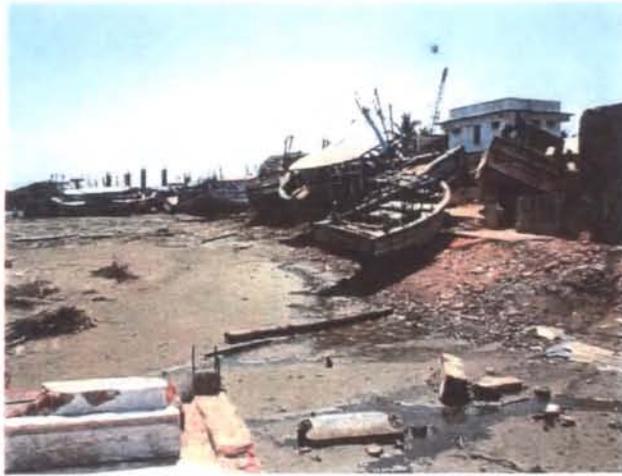
Photo 4.7 Damages to the boats on rear side of the vertical wall at Nagapattinam

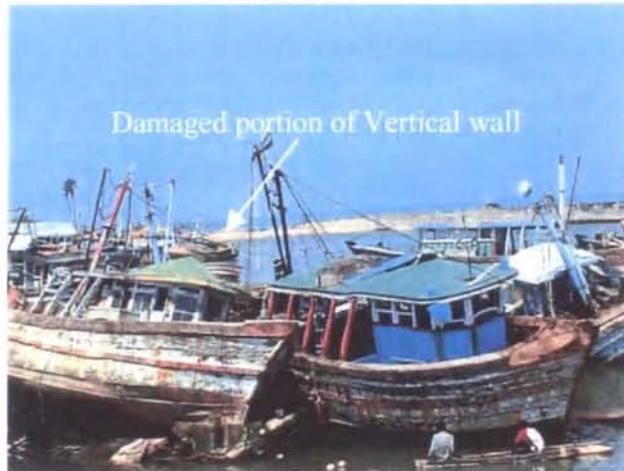
The barren land North of Nagapattinam port shown in **photo 4.5**, is an excellent place for dense plantations. The presence of the vertical wall (top level +2.7 m MSL) as shown in **photo 4.6**, constructed for the Nagapattinam port at a distance of about 60 m from the shoreline has acted as a barrier only marginally against the powerful tsunami. In spite of the presence of this wall, a number of boats were carried away to the land and water on its rear side has moved to a distance of 300 m and a height of about 8 m. The damaged boats behind the vertical wall are shown in **photo 4.7**, and the damaged portion of the vertical wall is shown in **photo 4.8**. The remedial measures are discussed in sec.4.1.2.

Photo 4.8 View showing the damaged portion of the vertical wall at Nagapattinam port

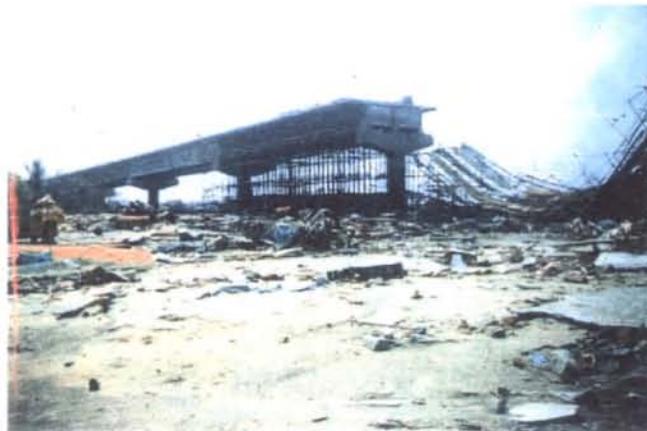
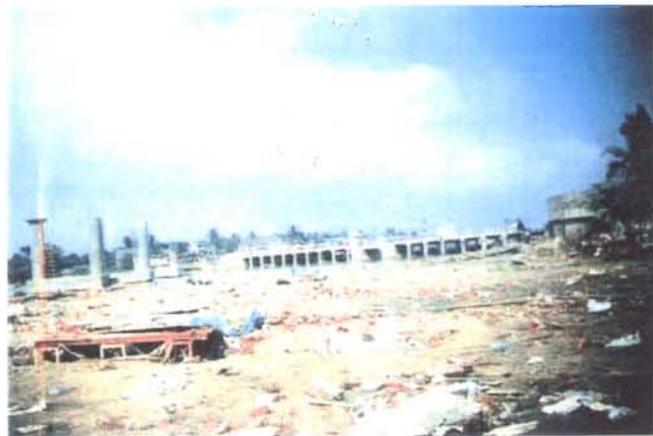
Photo 4.11 a & b Views of the damaged bridge connecting Nagapattinam and Kallar

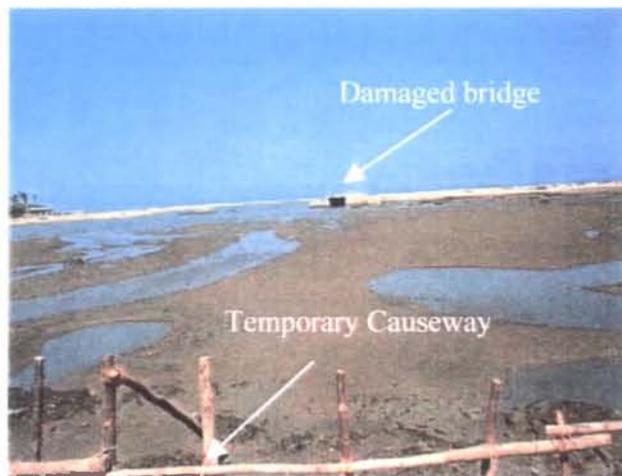
The damaged bridge connecting Nagapattinam and Kallar in the stretch 'B' is shown in photo 4.12. The hutments close to the beach have been washed away by the recent tsunami. A clear width of beach is available as can be seen in photo 4.13. The river Vellayar (photo 4.14) joins the sea adjacent to this stretch of the coast and is shown in the above photo. It is recommended to dredge the mouth of river Vellayar and nourish the beach on its Northern side as well as to construct a sand dune. Plantations backed up with sand dunes and masonry buffer blocks are recommended for this stretch of the coast as shown in the fig. 4.6. Both plan and sectional elevation of the proposed are shown in the above figure. The buffer blocks may also serve as a relaxing facility for the pilgrims and locals. After monitoring the shoreline for a period of about 2 years, a decision can be taken up on the necessity of a hard measure.

Photo 4.12. The damaged bridge connecting Nagapattinam and Kallar

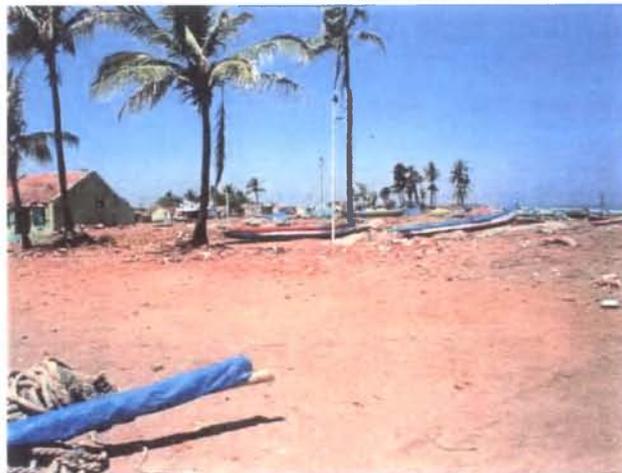
Photo 4.20. View of damages at Sathankudi after partial leveling of the debris

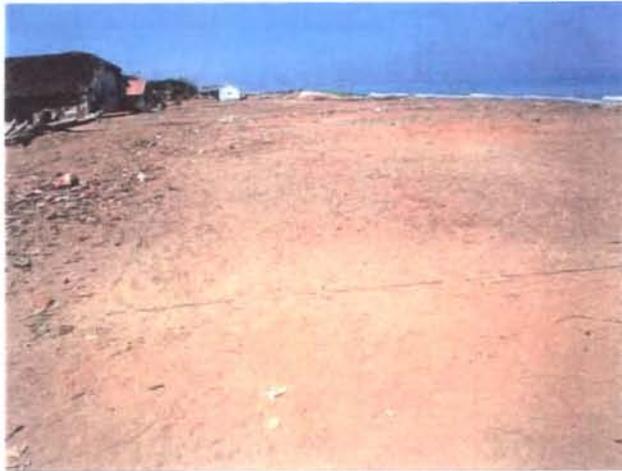
Photo 4.24. Damage to property North of Vaanagirikuppam

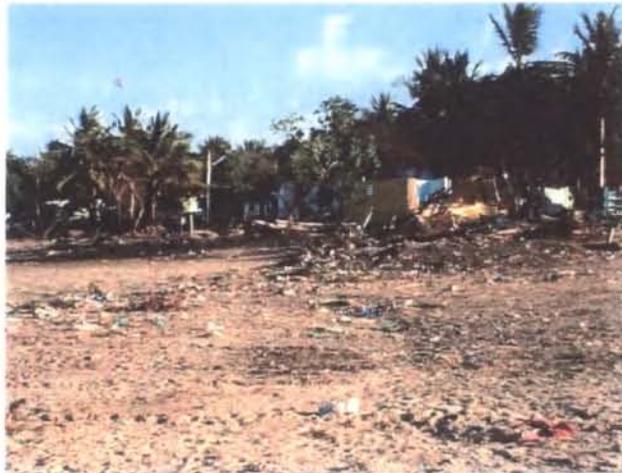
Photo 4.26. Typical damages to property due to tsunami at Palayur
