PROTECTION MEASURES FOR TAMILNADU COAST

Final Report

PUBLIC WORKS DEPARTMENT
GOVERNMENT OF TAMILNADU

Prof. V. SUNDAR
&
Prof. R. SUNDARAVADIVELU

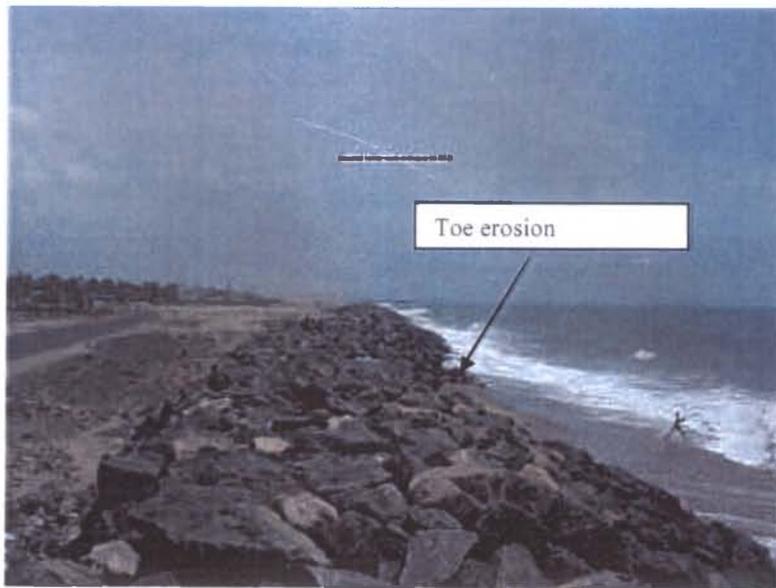
Photo. 1.2. Seawall beyond Ernavur experiencing toe erosion

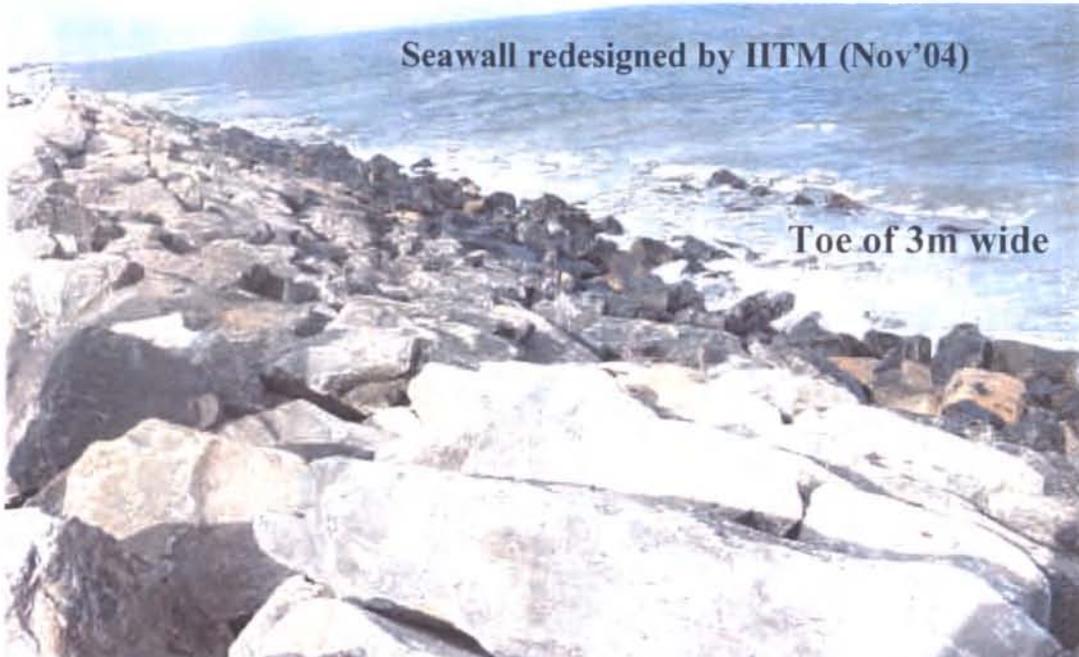
toe for seawall is very essential as in the case of the seawall for a particular stretch, north of Chennai harbour shown in **photo.1.3**. In locations, where, large size natural rocks is scanty, gabions (wire net filled with stones of smaller size) as shown in **photo.1.4** can be adopted. At locations of abundance of sand (near river mouths which may be dredged as a part of river training works) Geo-bags or Geo-tubes can be adopted as can be seen in **photo. 1.5**.

Photo. 1.3 Seawall with toe protection north of Ernavur

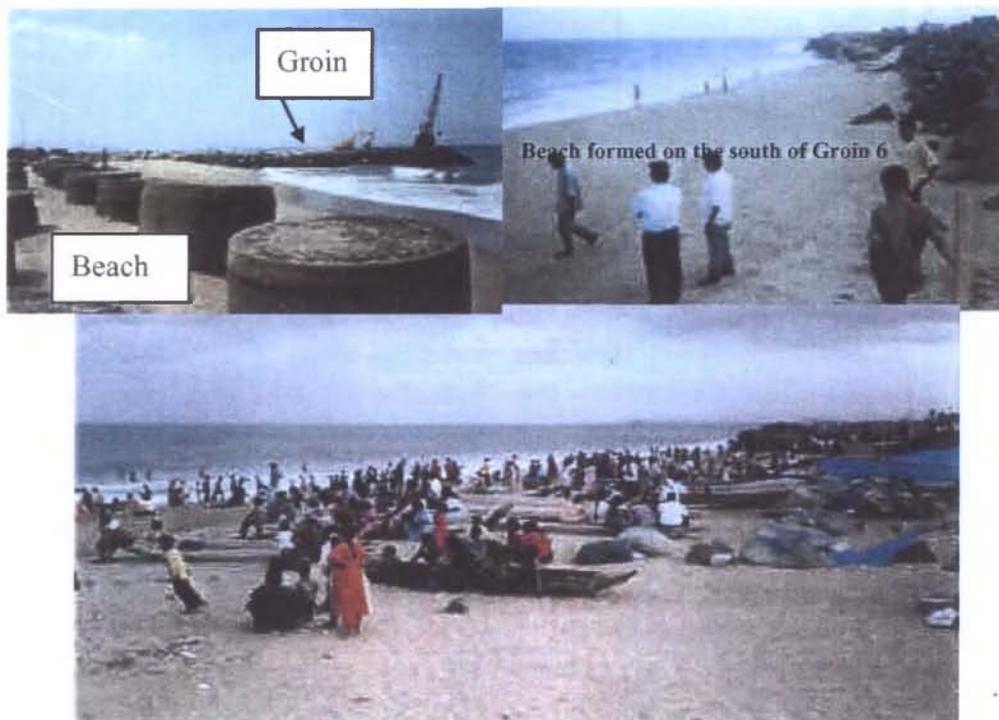
Photo. 1.10. Effect of Groin field in winning the beach (Royapuram, Chennai)

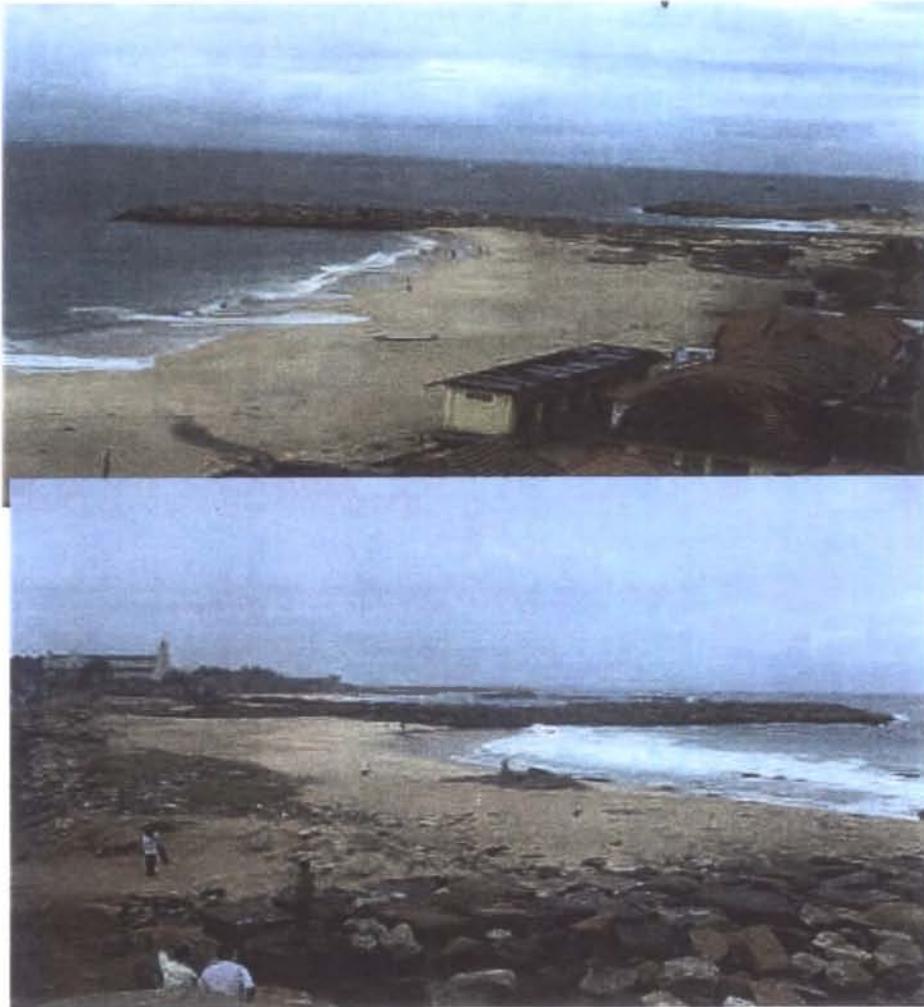
Photo.1.11. Effect of groins as an effective coastal protection measure (Kanyakumari District)

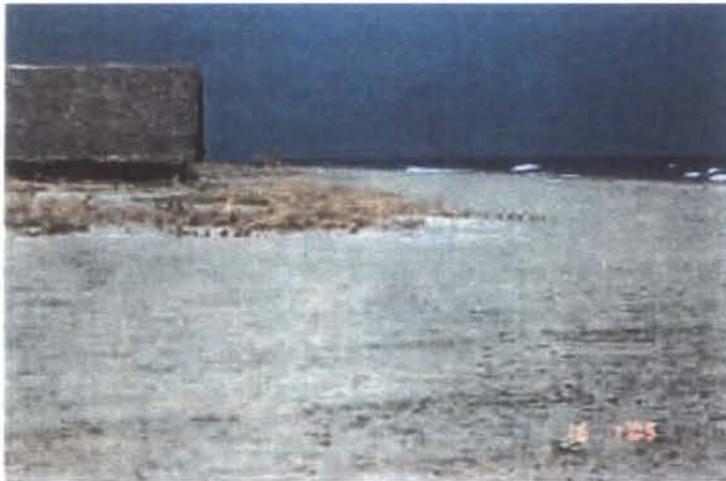
This village is situated on the north of Ennore Port and south of Pulicat lake. During tsunami, water wall of height 3 m has penetrated about 300 m into the coast. A view of the present beach at Kaatupallikuppam is shown in photo 2.1. The stretch of the coast north of Ennore along with the location of this village is shown in fig.2.1. As the Ennore port breakwaters are intercepting the net northerly littoral drift, there is slight erosion at this village. This erosion may be magnified if not tackled. Hence, soft measures like plantations and sand nourishment (dredged spoil from Ennore port) are recommended

Photo.2.1. A view of beach at Kaatupallikuppam

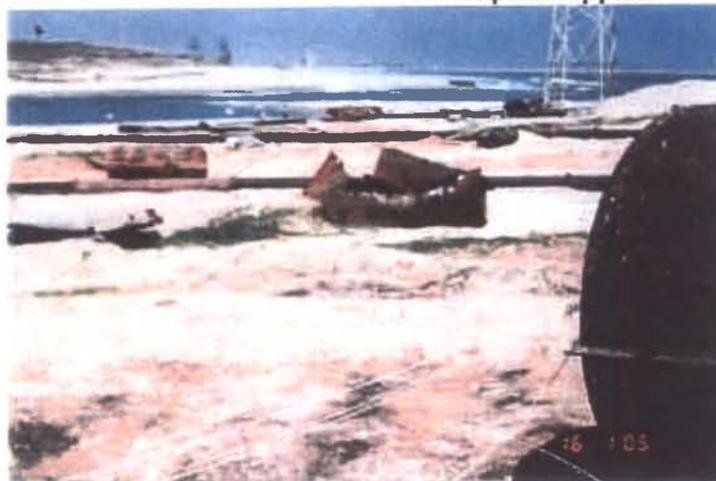
The river Kosasthalayar discharges into the Bay of Bengal at Ennore. The Ennore port is located on the north of this river mouth. The breakwaters of Ennore port are acting as permanent littoral barriers and hence trapping the sediments in to the river mouth. These trapped sediments have choked the river mouth. However, during the tsunami, the mouth of this river was opened due to the penetration of water mass from the ocean which is shown in photo 2.2. Presently, the dredging in full swing is in progress as can be seen in photo 2.3, in order to keep the river mouth open. During the site visit, it was seen that the dredged spoil was being disposed on the south of the mouth of the Ennore creek, which was found resettling into the mouth. This exercise is futile as it is clear that the net littoral drift along the East coast of India is directed towards north. In order to achieve a better solution two groins one on each side of the mouth as training walls need to be

Photo 2.2 A view of the sand bar formation at the mouth of Ennore

constructed. The southern groin can extend upto a water depth of about 5m, whereas, the northern groin can extend upto a water depth of 4m. The approximate lengths of the two groins could be about 250m and 200m. In addition, a sand trap on the south of the southern groin is proposed. A schematic representation of the stretch of the coast from Chennai harbour to Ennore port along with the completed groin field for stretch I taken up by the Tamilnadu Road development Company (TNRDC) along with the proposed groins for stretch II are depicted in **fig.2.2**. The details of the proposed tentative Ennore mouth improvement scheme which includes a sand trap south of the southern groin are shown **fig.2.3**.

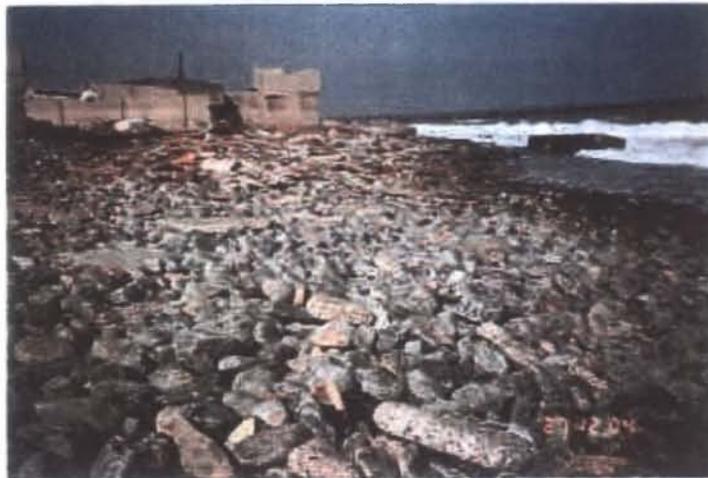
Photo 2.5. A view of the existing depleted seawall

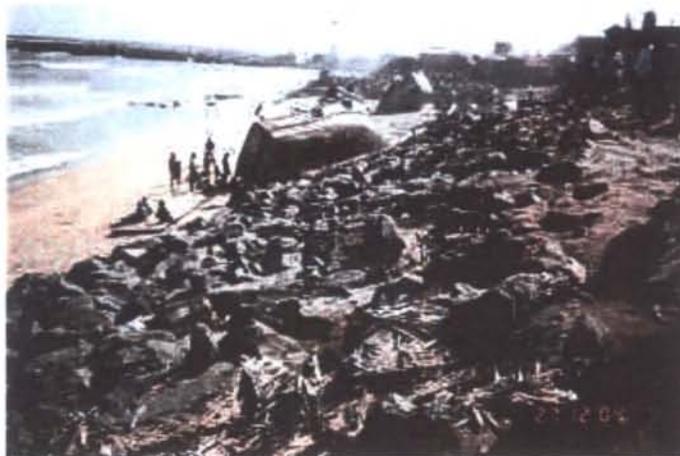
Photo 2.6. A view of the existing depleted seawall north of Chennai fishing harbor

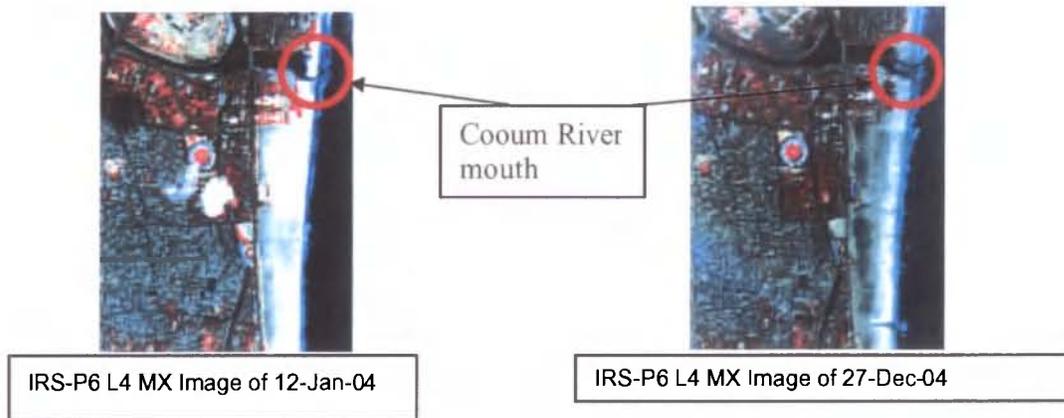
Photo 2.7 Status of river Cooum a) Before b) After tsunami

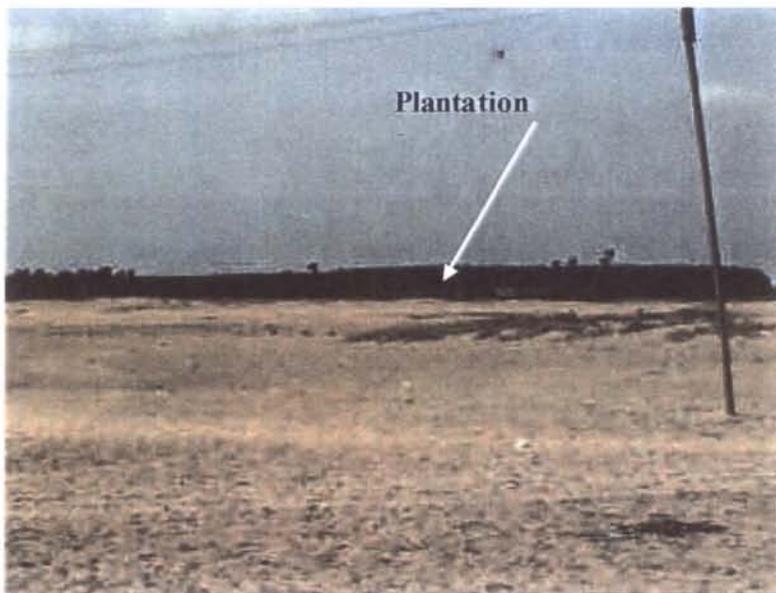
Photo 2.21. Dense plantations in between Chinna Kuppam and Voyyal Kuppam

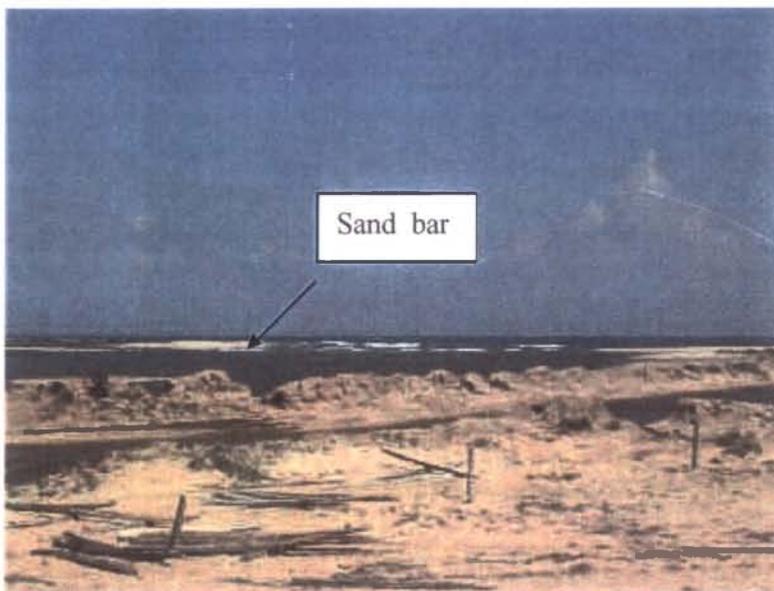
The width of the beach south of river Palar of Chinnakuppam is shown in **photo. 2.20**. However, this area is experiencing only marginal erosion. **Two training walls upto a water depth of about 4m near the mouth of the river Palar is recommended.** The training walls of river Palar will stabilize the beaches of Chinnakuppam and Periyakuppam. After monitoring the shoreline evolution due to these training walls, a decision can be taken to provide further protection. As a long-term solution, **plantation can be started in between these two villages, as there is enough barren land.** The plantation can be as dense as shown in **photo. 2.21**, the location of which in between these two villages, is slightly far away from the shoreline. The Palar river mouth which was discussed earlier shows the formation of shoals and sand bar near its mouth (**photo. 2.22**) which needs two training walls as shown in **fig. 2.12**.

Photo 2.22. Sand bar formation at the mouth of river Palar

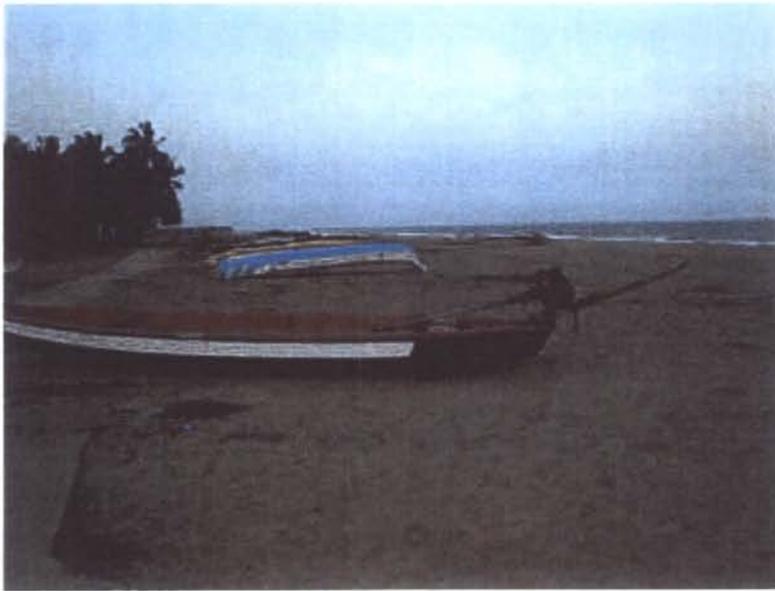
The beach widths along this stretch are shown in photos 2.29 and 2.30. This stretch exhibits the existence of sufficient beach width for which a soft measure like plantation should be taken up immediately. Damages due to tsunami are shown in photo.2.31.

Photo 2.29. The beach width North of Mudhaliyarkuppam

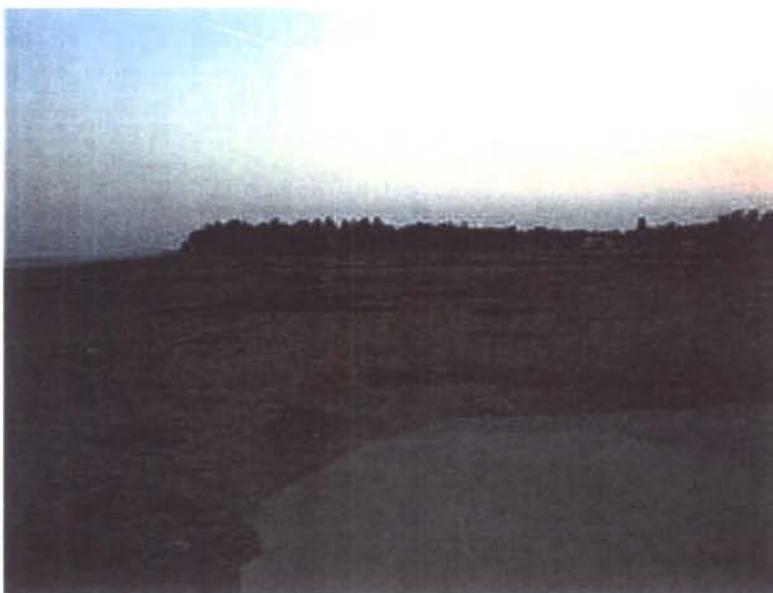
Photo 2.30. The beach width South of Mudhaliyarkuppam

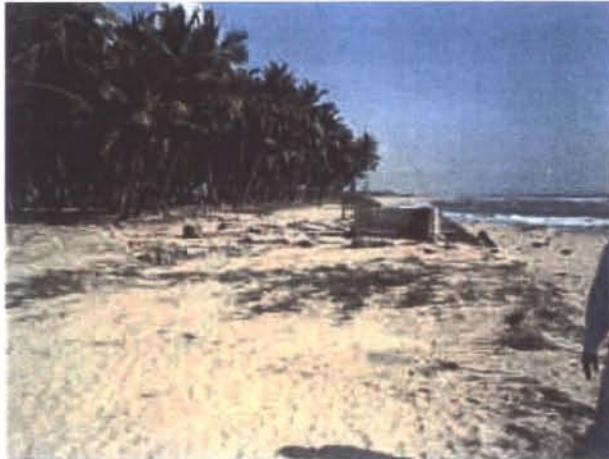
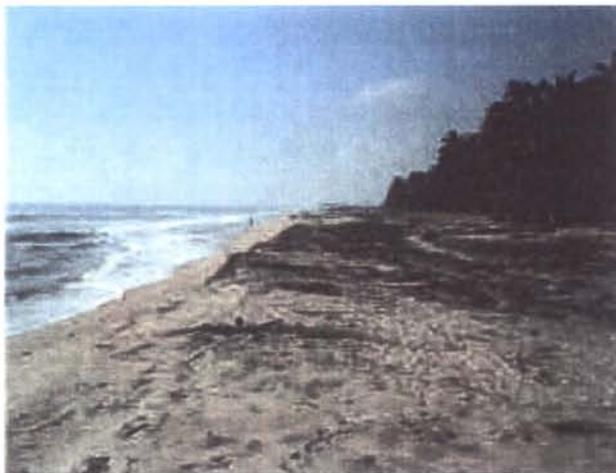
The views of the beach north and south of this village are shown in photos 2.32 and 2.33 respectively. Although, the beach is about 30m wide and coconut trees have given some amount of relief, about 300 to 400 families living in this village have suffered loss of property and life due to the tsunami. The PWD officials have stated that, the beaches formed during the visit get eroded during other seasons. The tsunami has removed all the beaches upto the coconut trees and a number of coconut trees and houses were completely damaged. (photos 2.34a and 2.34b). There is an urgent need to protect this coast. The village is also not at an elevated location. The river (pennaiyar) training works would consist of a pair of training walls of lengths of about 250m which need to be constructed that has to be discussed with the Government of Pondicherry as the stretch on the north of mouth of this river comes under the jurisdiction of state of Pondicherry. On the southern side of the mouth, a long groin is proposed followed by a groin field for a distance of about 3km upto Devanampatinam. This would consist of 10groins with an average length of about 150m. The PWD officials have started temporary protection measures by driving trunks of Palma rah trees parallel to the shoreline (photo 2.35). The trunks are of 6m length and driven 4m into the sea bed. If these trunks had only been driven normal to the shoreline, at regular intervals, it would have served as a permeable groin field allowing the sand to get deposited in between them leading to the formation of a beach. The respective S.E of PWD has been advised accordingly. photos 2.36 a & b show the choking of the mouth of pennaiyar river. Nearly 350 people have died in these villages and hence for a stretch of 3km needs protection with a combination of groins and a high crown seawall. Only the concept of the protection measure to be adopted for the stretch of the coast between Thazhanguda Village and Devanampatinam are shown in fig.2.16. Initially the groins should be constructed, followed by the seawall after

Photo 2.32 & 2.33. Beach widths North and South of Thazhanguda

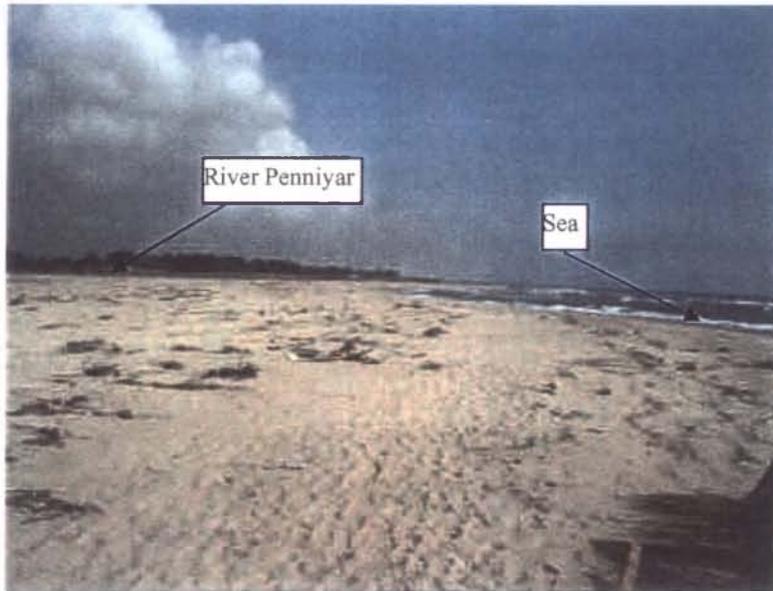
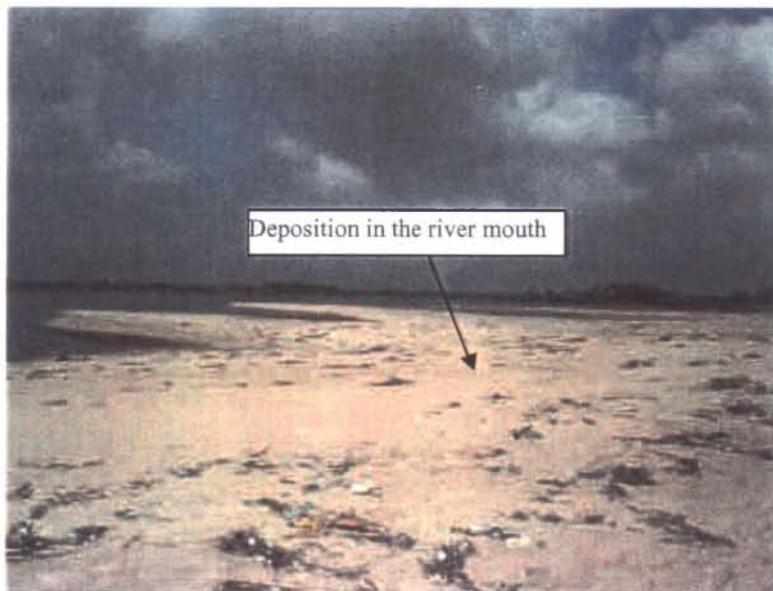
Photo 2.36 a & b. Deposition at the mouth of river Penniyar near Thazhanguda

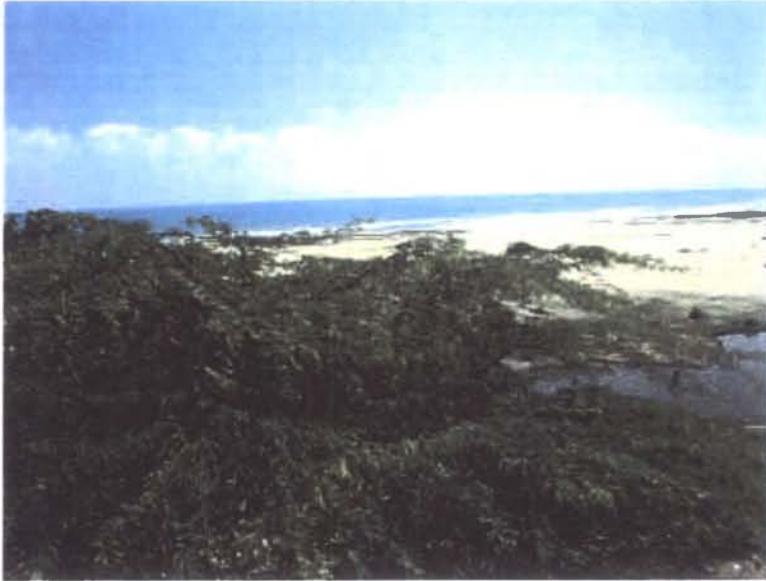
The north of the northern breakwater of this port has a wide-open barren land (photo.2.37), which can be protected with plantation. The houses are in a much-elevated location. The tsunami has not reached the dwelling units from the sea. However, most of the damages to the village Singarathoppu, located close to the banks of Uppanar river (fig.2.17), from which the tsunami penetrated to result in a huge damage. Hence, immediate steps are to be taken to shift the dwelling units to the elevated locations.

Photo 2.37. Open Barren land north of Cuddalore port

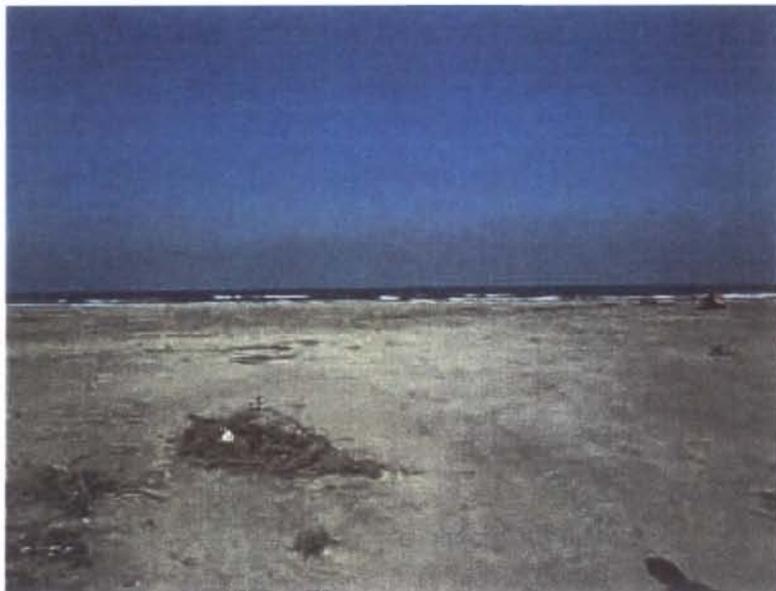
During the tsunami, water penetrated about 1km into the land, causing a death toll of about 200 and severe damage to the property. The beach is very flat (photo 2.38) for a stretch of the coast of 10km north of Parangipettai upto Samiyarpettai. The houses are located at a distance of about 500m from the shoreline except for a public convenience shown in photo 2.39 that had been completely submerged during the tsunami. The barren land shown in this stretch of the coast as can be seen in photo.2.40 has not offered any protection from the tsunami run-up. Hence, dense plantations are proposed. As dwelling units are located mostly about 200m away from the shoreline and as the seabed is very flat, without much shoreline oscillations as per the information gathered by local public, conventional hard measures like seawalls or groin field would not serve as coastal protection measure. In the case of groins, they have to be quite long in order to pierce the surf width. In the event of tsunami, the aim of the protection measure should be to reduce its speed, for which masonry buffer blocks (4m x 0.5m x 0.5m) and can be constructed in two rows at a distance of 200m from the shoreline and in between these blocks and shoreline plantation as already mentioned could act as front line soldiers to reduce the speed. The priority in this case would be plantations followed by the buffer blocks. The concept are projected in fig. 2.18.

Photo 2.38. Flat beach at Pudukuppam

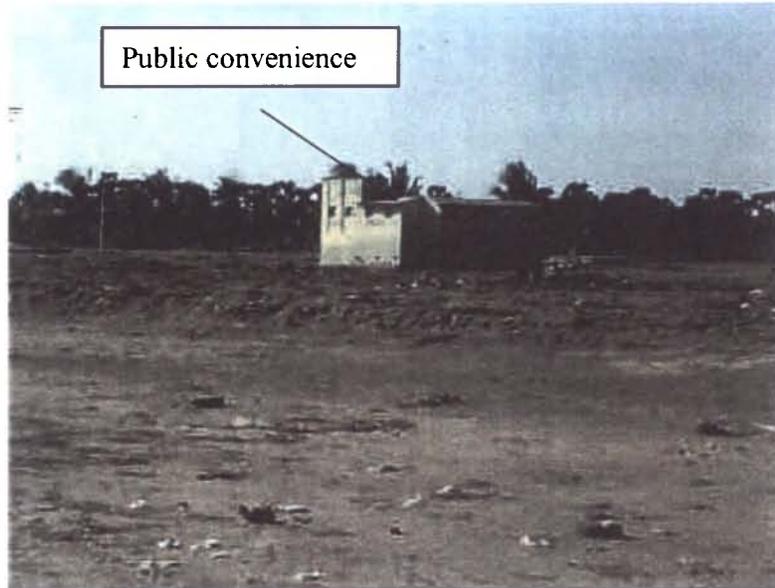
Photo 2.39. View showing the public convenience adjacent to shore

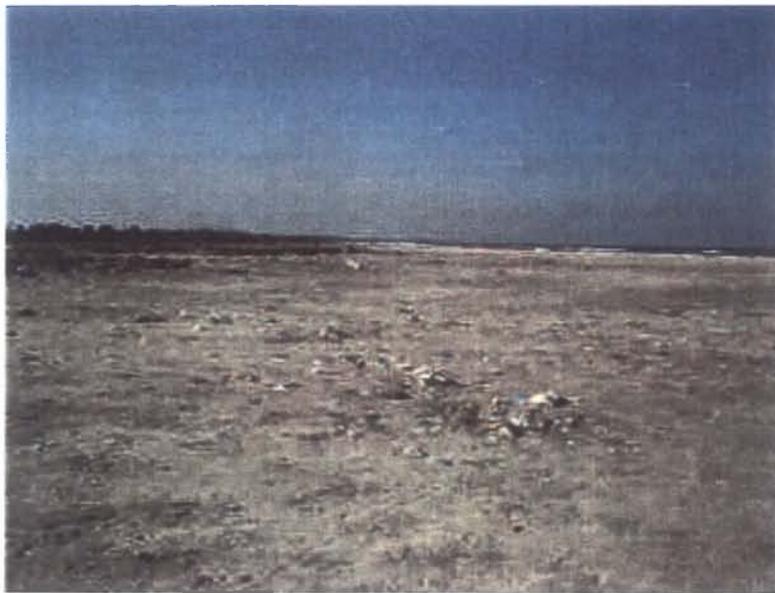
Photo2.40 Barren land adjacent to shore at Pudukuppam.

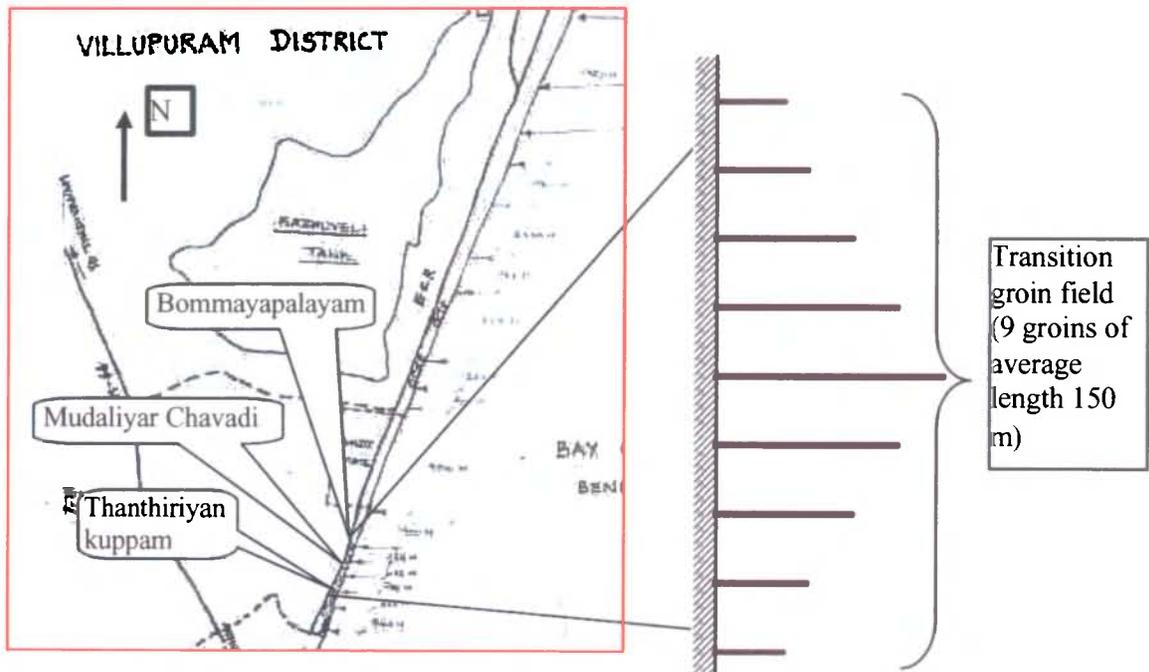
Fig. 2.15 Transition groin field for the stretch of the coast north of Thanthiriyankuppam

The damages near this village are shown in photo.2.28. From this village, a stretch of about 3.5km north of this village (Muthialpet, Mudaliarchavadi, Bommayapalyam) is densely populated and hence need to be protected with a groin field (fig.2.15). The groin field will consist of 9 groins with an average length of 150m. Sandy beaches are also available at a few pockets, where, plantations can be done as a long-term measure for the protection of the coast. The width of the beach from Muttukaadu Azhagankuppam to Mudaliar Chavadi in Villupuram district after the tsunami is provided in Table. 2.1.

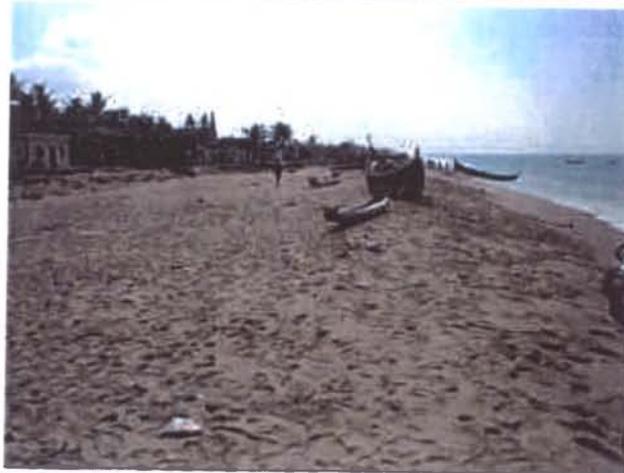
This stretch of the coast from Neerodi colony to Erayamunthurai, situated in the West coast of Tamilnadu state is shown in **fig. 3.2**. A number of dwelling units just close to the coast are facing threat of erosion. The width of the beach along this stretch of the coast is about 30 m as can be seen from the **photo 3.1**, gets washed away during the South-West (SW) monsoon leading to the entering of seawater occasionally into the dwelling units. It is observed that the beach slope in this stretch is quite steep. An existing sea wall for a length 1km is in a collapsing stage.

Photo 3.1 View showing the width of the beach at Neerodi Colony

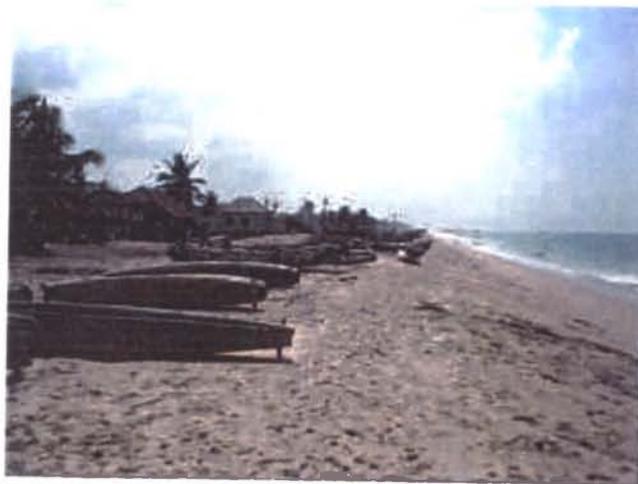
The stretch of the coast from Neerodi colony to Erayumanthurai covering a total distance of about 8 Km have already been protected by a seawall (**photo 3.2**), which has sunk.

Photo 3.2 View showing a number of catamarans parked adjacent to beach at Marthanduthurai

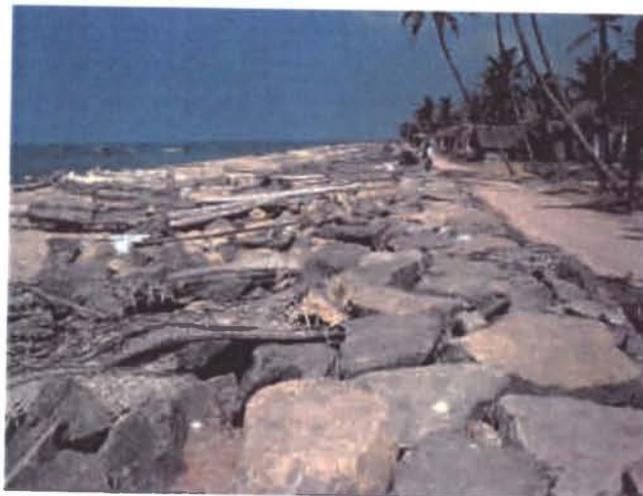
The seawall constructed by PWD based on the design of IIT Madras, is found to be intact with the beach width of about 15 m in front of the seawall (**photo 3.3**). The top of the seawall is found to be effectively used by fishing community for drying fish as can be seen in **photo 3.4**.

Photo 3.3 The existing seawall at Chinnathurai

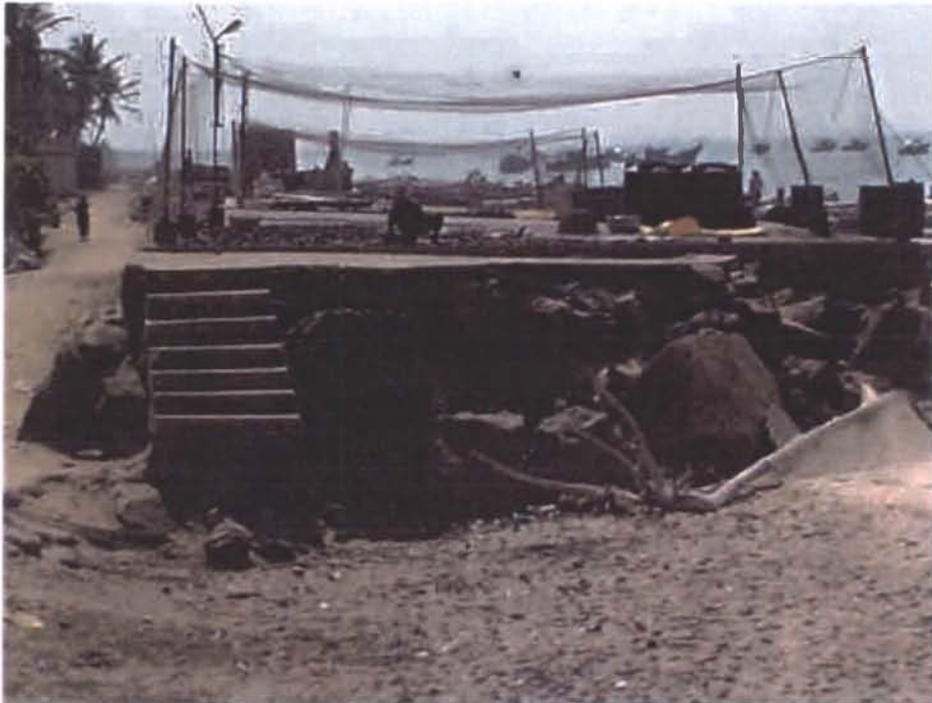
Photo 3.4. The top of the seawall being effectively used by fishing community

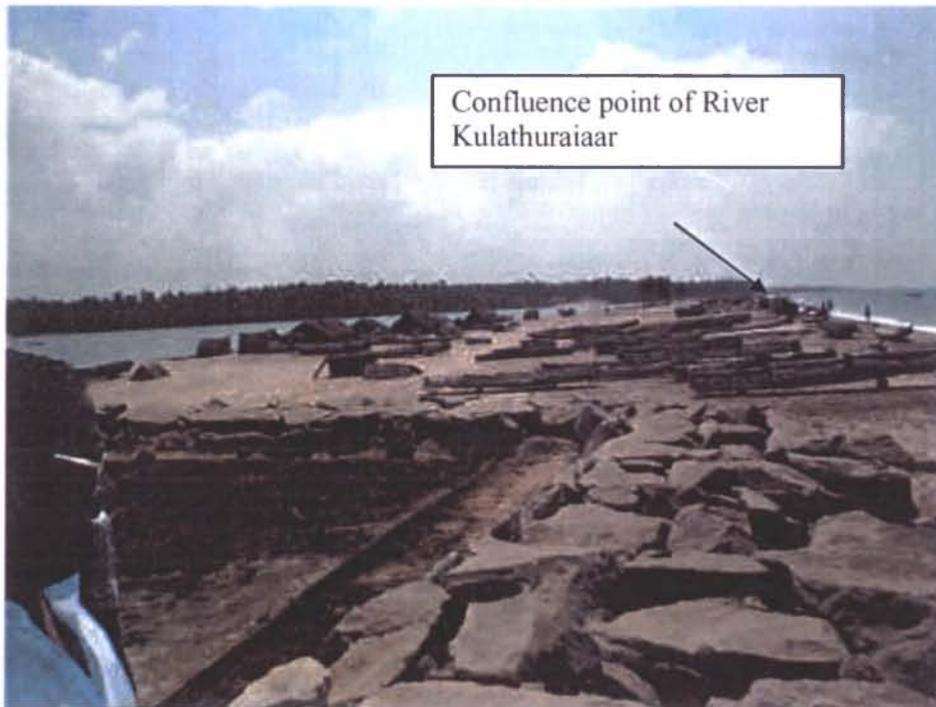
This hamlet is located on the Western side of the confluence point of the river Kulithuraiaar (photo 3.5). For all of the above stretches it is recommended that the existing seawall should be stabilized or replenished, in particular Poothurai and Erayumanthurai which got affected due to tsunami. Also, it is further recommended to fill the gaps between the seawalls as it is reported by the local public that these gaps allowed the tsunami into the land which caused damage. It is to be recalled that the existing depleted seawall has to be rehabilitated including the raising of the top level to +5.35 m above MSL similar to that in Vallavalai. *The scheme suggested for protecting the entire stretch from Neerodi colony to Erayumanthurai as a long term measure would be to protect with about 15 groins with an average length of about 200 m as shown in fig. 3.3.. However, this remedial measure can be taken up under phase II.*

Photo 3.5 View showing the confluence point of river Kulathuraiaar at Erayumanthurai

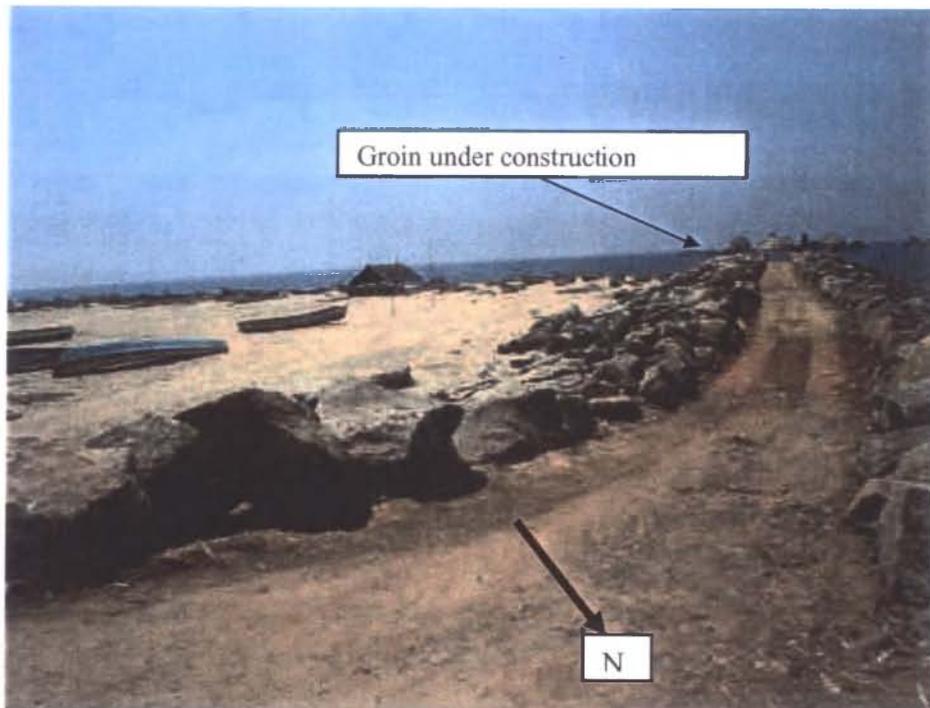
The enlarged version of the stretch of the coast from Enayam to Muttam is shown in fig. 3.4. A groin at Enayam is in progress and is likely to be completed by April, 2005. The beach formed on the Eastern side is being used for parking the boats as can be seen in photo. 3.6. The western side of this groin has a number of dwelling units very close to the shoreline facing a constant threat due to the progressive ocean waves (photo 3.7). The seawall constructed is not effective in protecting the coast. The groin under construction, as per the local people, has saved the village on its lee side due to tsunami. Because of the presence of this groin, the propagation of tsunami on its western side must have been attenuated, and hence there was no damage to dwelling units adjacent to the shoreline. A distance of 1 Km on the West of this groin has to be protected by groin field consisting of 6 short transition groins with an average length of 75 m as shown in fig 3.5

Photo 3.6 View showing the beach formed on the Eastern side of the groin under construction at Enayam

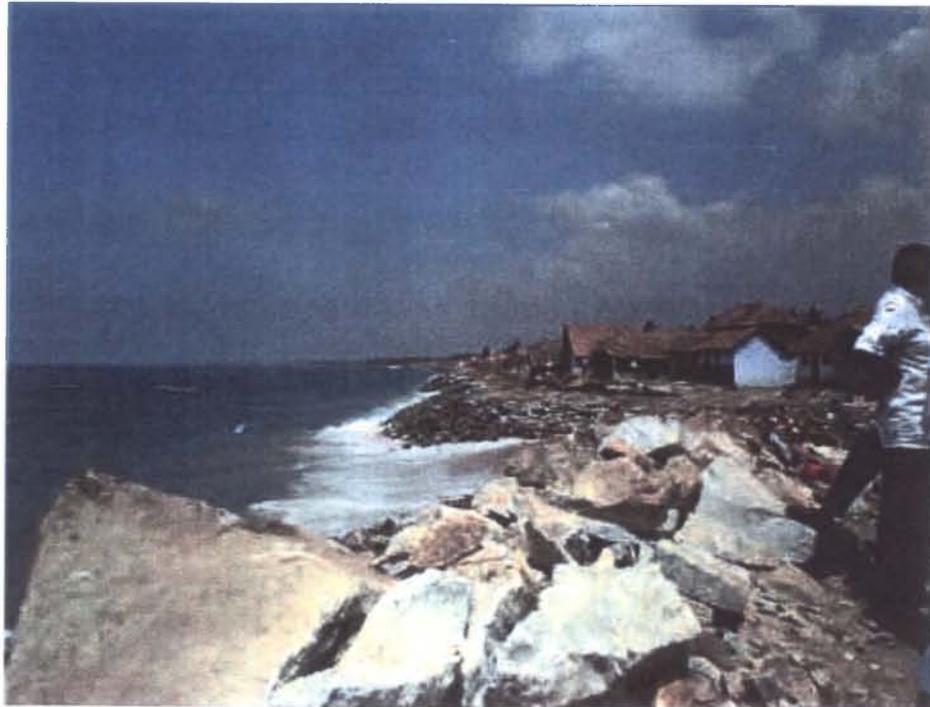
Photo 3.7 A number of dwelling units on the Western side of the groin, under threat

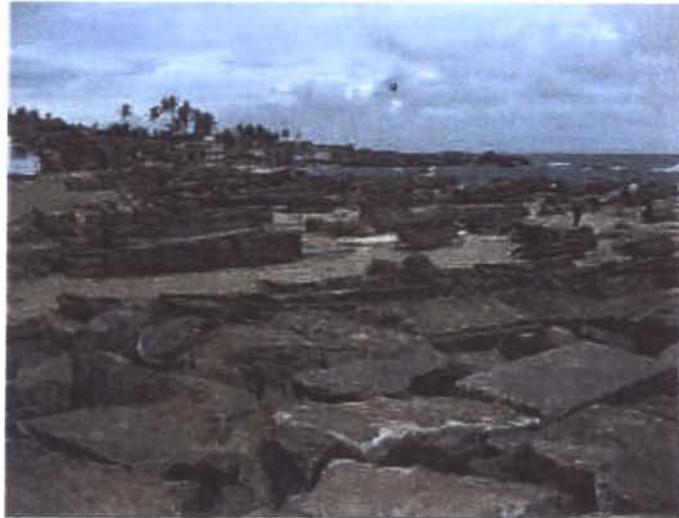
G7-G8 (photo 3.8) so as to serve as an additional groin is still pending with the PWD. This recommendation may be taken by PWD immediately. The above said recommendation is shown in fig.3.6.

Photo 3.8 Outcrops east of G1G2 of Kurumbunai to connected to serve as a groin

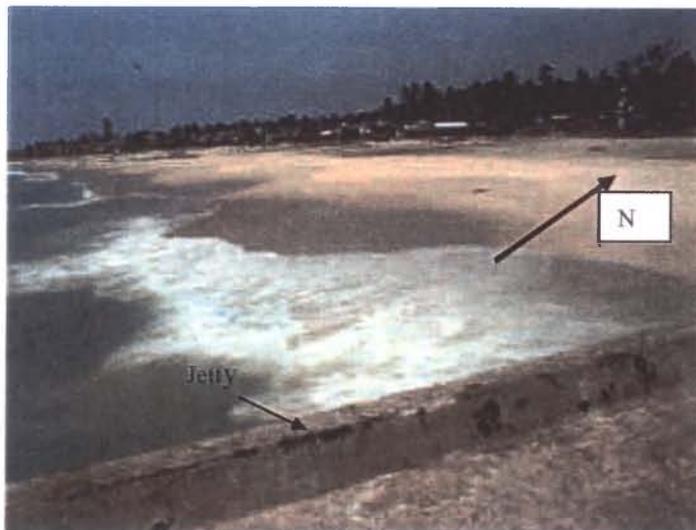
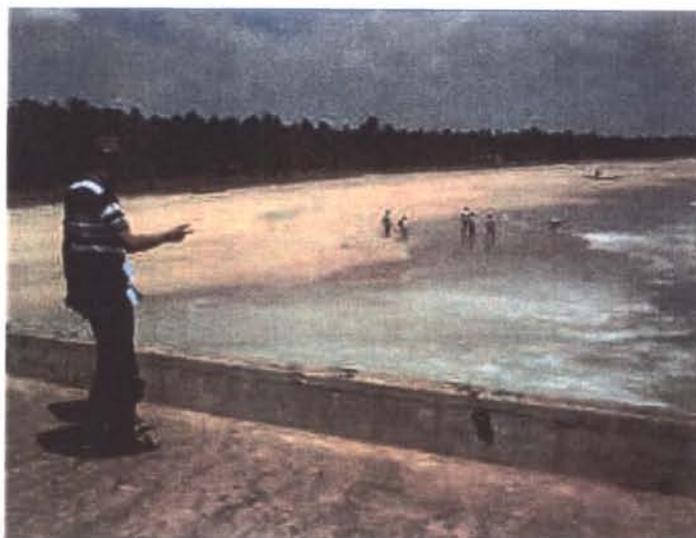
The beach is found to be very flat on either side of the jetty as can be seen in photos 3.9 and 3.10. The beach can be used for plantations. A pair of groins with a crest elevation of about 6.0 m from MSL locally called as thoondil valaivu can serve as a protection measure against severe waves particularly during cyclones and natural hazards. This proposal will also serve as a landing facility for boats and catamarans, the concept of which is projected in fig.3.7. The existing jetty can more effectively be used if the above proposal is implemented. The length of the coast that should be covered under this proposal will be about 1km. The effect of the penetration of tsunami on the flat beach is shown in photos 3.11, 3.12 and 3.13, which shows the damaged buildings about 100 m from shoreline, beyond the existing road.

Photo 3.9 View of the flat beach on western side of Colachel Jetty

Photo 3.10 View of the flat beach on Eastern side of Colachel

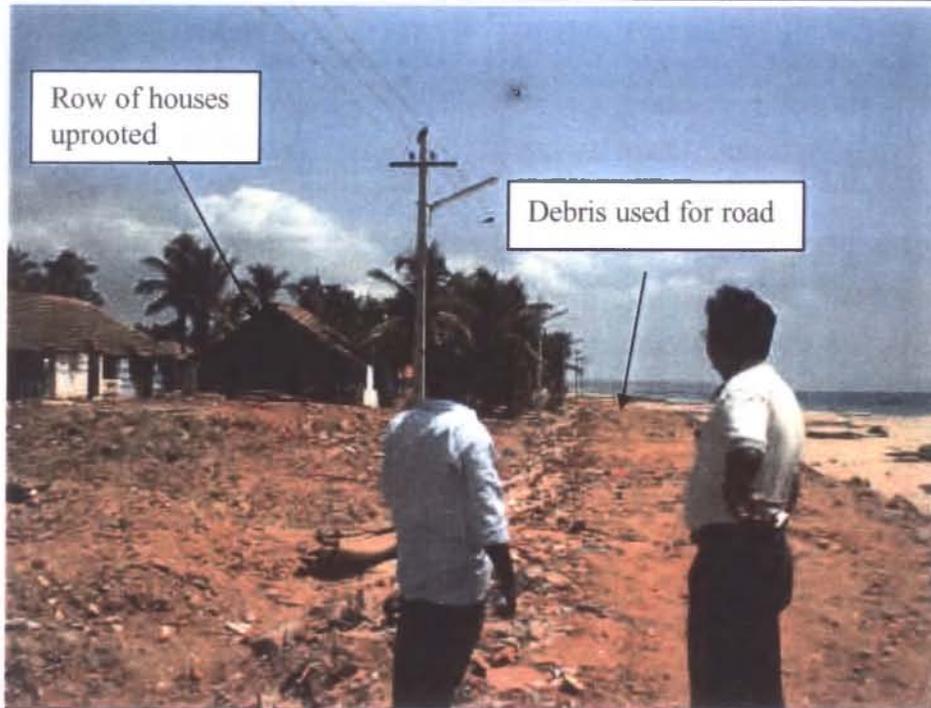
This is one of the worst affected villages of the coast of Kanyakumari district due to tsunami and has resulted in a number of casualties about 200. About 4 rows of houses collapsed is shown in photo 3.14. A road is formed with the debris removed along the coast as seen in the above photo. The local public have reported that the canal, which is running parallel to the shoreline has acted as a death trap, as the people trying to escape from the attack of the tsunami should have got stranded and drowned as the number of bridges or escape routes available are less. The measurements of certain important area were made and the plan showing these details is shown fig. 3.8. This area needs to be protected against wave run-up during cyclone and tsunami. Local people are strongly recommended to move on to the landward side of the canal. This has to be treated as the most urgent strategy. In case the implementation of the above stated strategy is not possible, the following are recommended.

Photo 3.14 View showing a road formed with the debris removed along the coast at Kottipadu

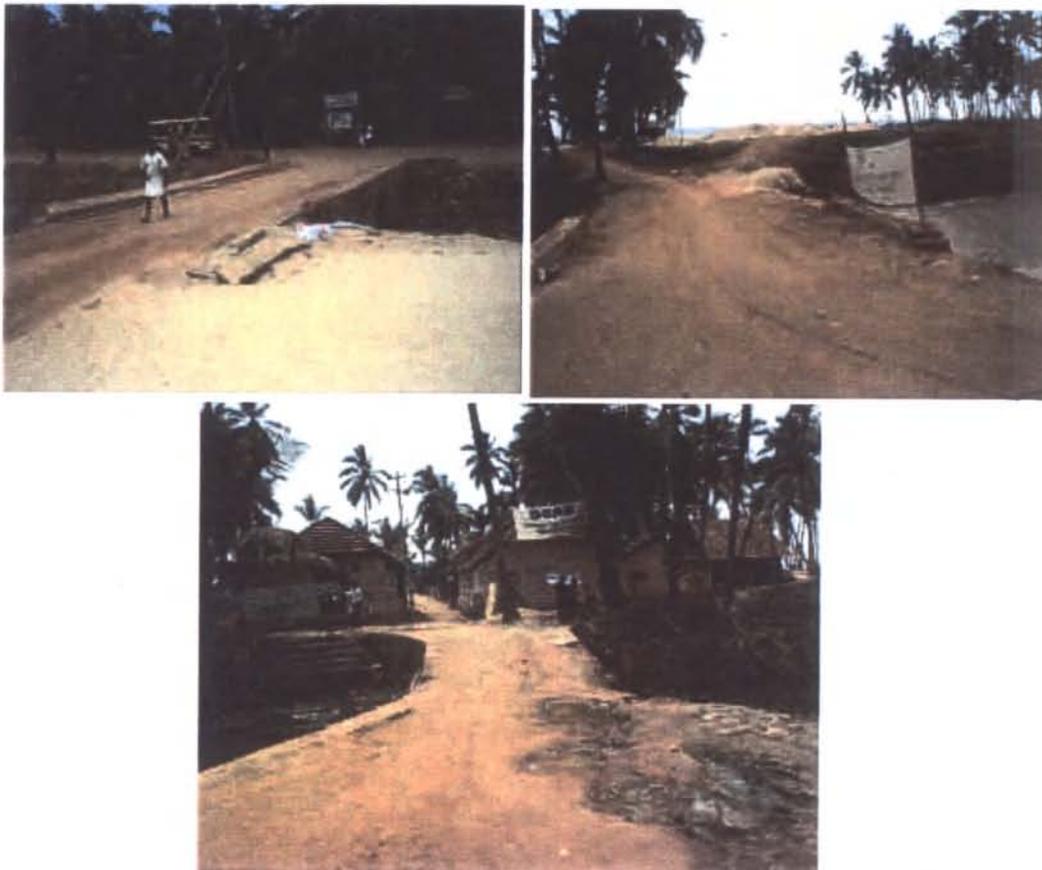
Photo 3.15, a, b & c. Views of the bridges at Kottipadu, Colachel.

- One more bridge adjacent to the existing one, with a higher deck slab of atleast about 1m above the present level and of greater width is recommended. The existing bridges are shown in photos 3.15 a, b & c.

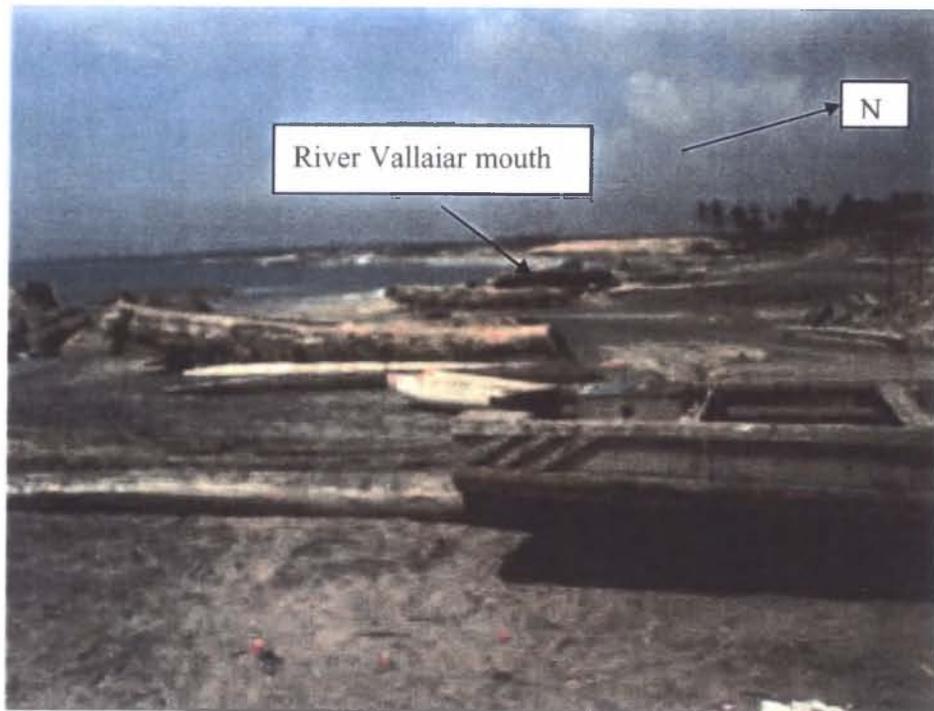
This stretch of the coast lies at the confluence point of the river Valliar (photo 3.16). It is proposed to construct two groins as training walls for this river mouth as shown in fig.3.10. The existence of natural outcrops can be seen in the photo 3.17, if supplemented by rock fill to serve as groin, should be considered.

Photo 3.16 The confluence point of the river Valliar at Kadiapattinam

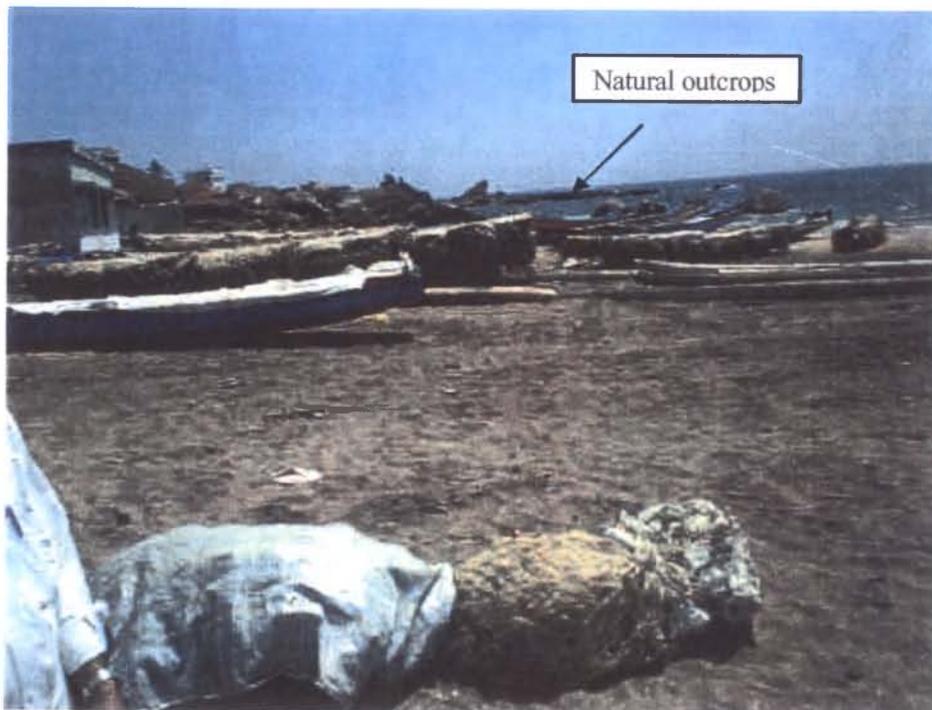
Photo 3.17 Rocky outcrops acting as groins near Kadiapattinam
