PROTECTION MEASURES FOR TAMILNADU COAST

Final Report

PUBLIC WORKS DEPARTMENT
GOVERNMENT OF TAMILNADU

Prof. V. SUNDAR
&
Prof. R. SUNDARAVADIVELU

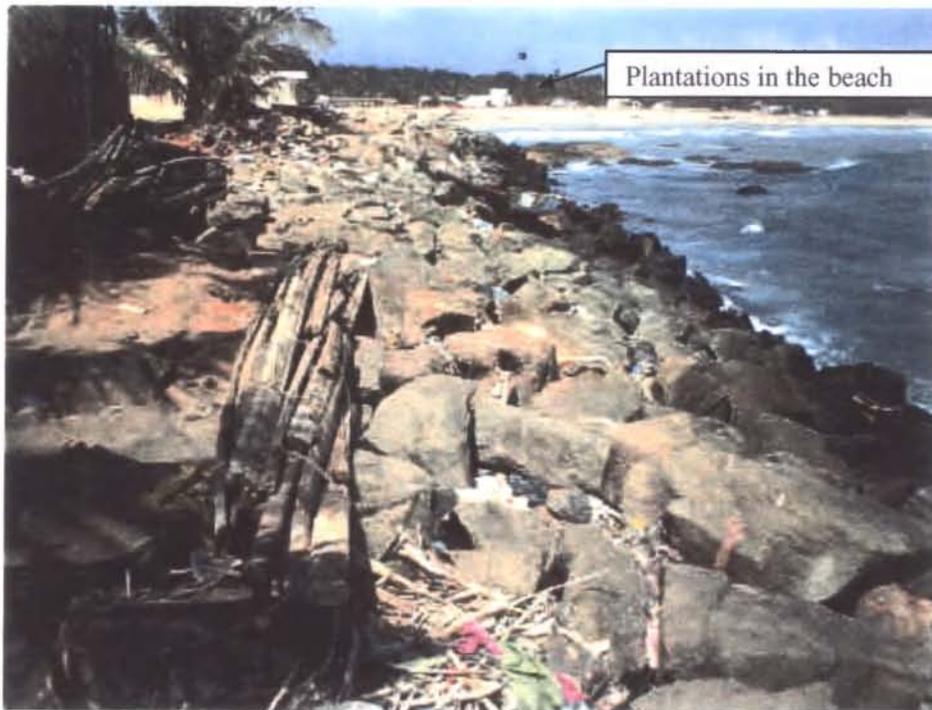
Plantations are recommended on the East of Muttam stretch consisting of Pillathopputhurai, Melathurai and Alikkal. A close view of the existing seawall at Muttam is shown in photo 3.18. The crest of the seawall and land along this stretch are at same elevation. During monsoon, overtopping is reported by the local people. *Hence, raising of the crest elevation by about 1 m is recommended (II. nd phase).*

Photo 3.18. A close view of the existing seawall

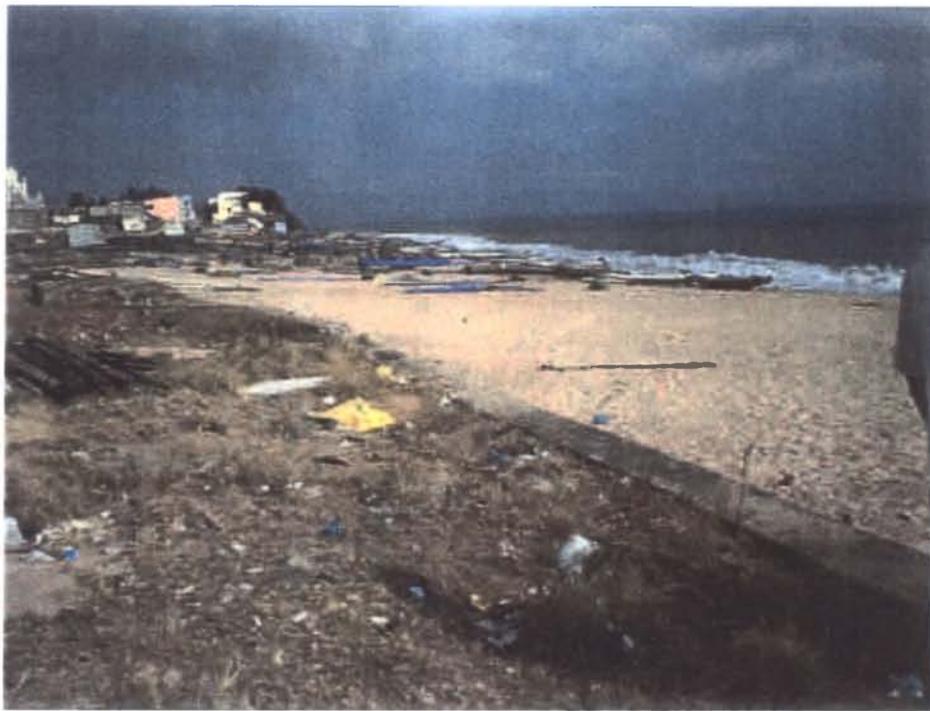
Damages to the houses land ward side of the shore is shown in photo 3.19. The beach which is formed, where the catamarans are parked as can be seen in photo 3.20, is of

Photo 3.20 View of the seasonal beach where catamarans are parked

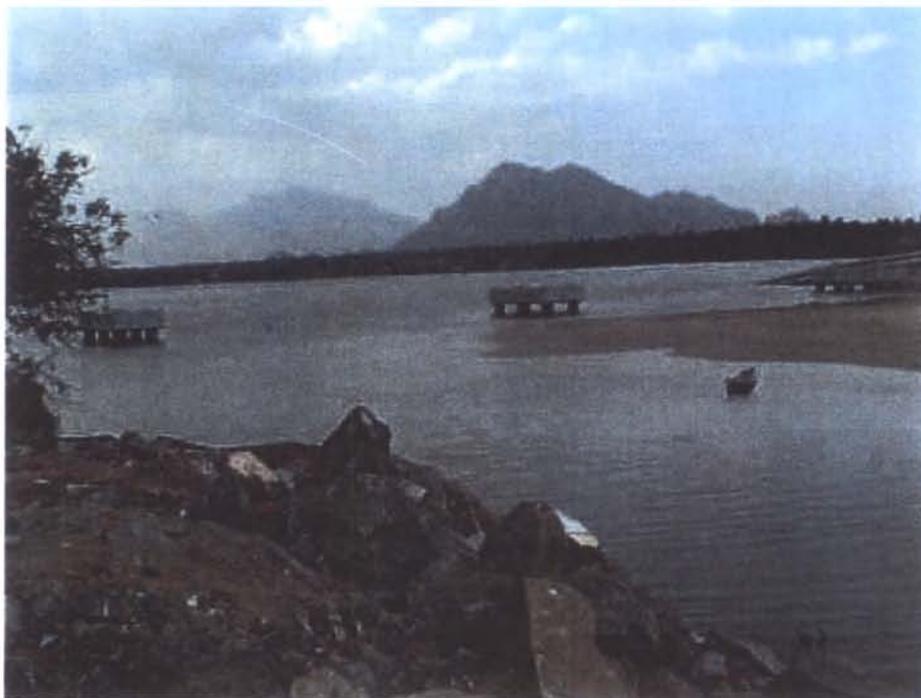
Photo 3.25. The collapsed bridge on Palayar river

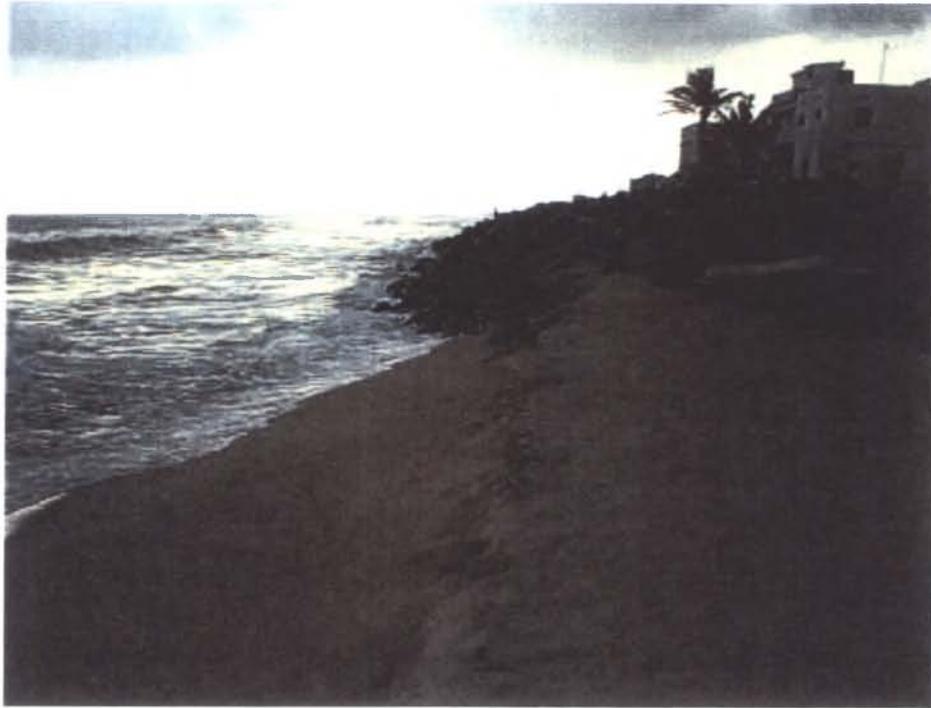
Photo 3.26. Erosion at the tip of the seawall

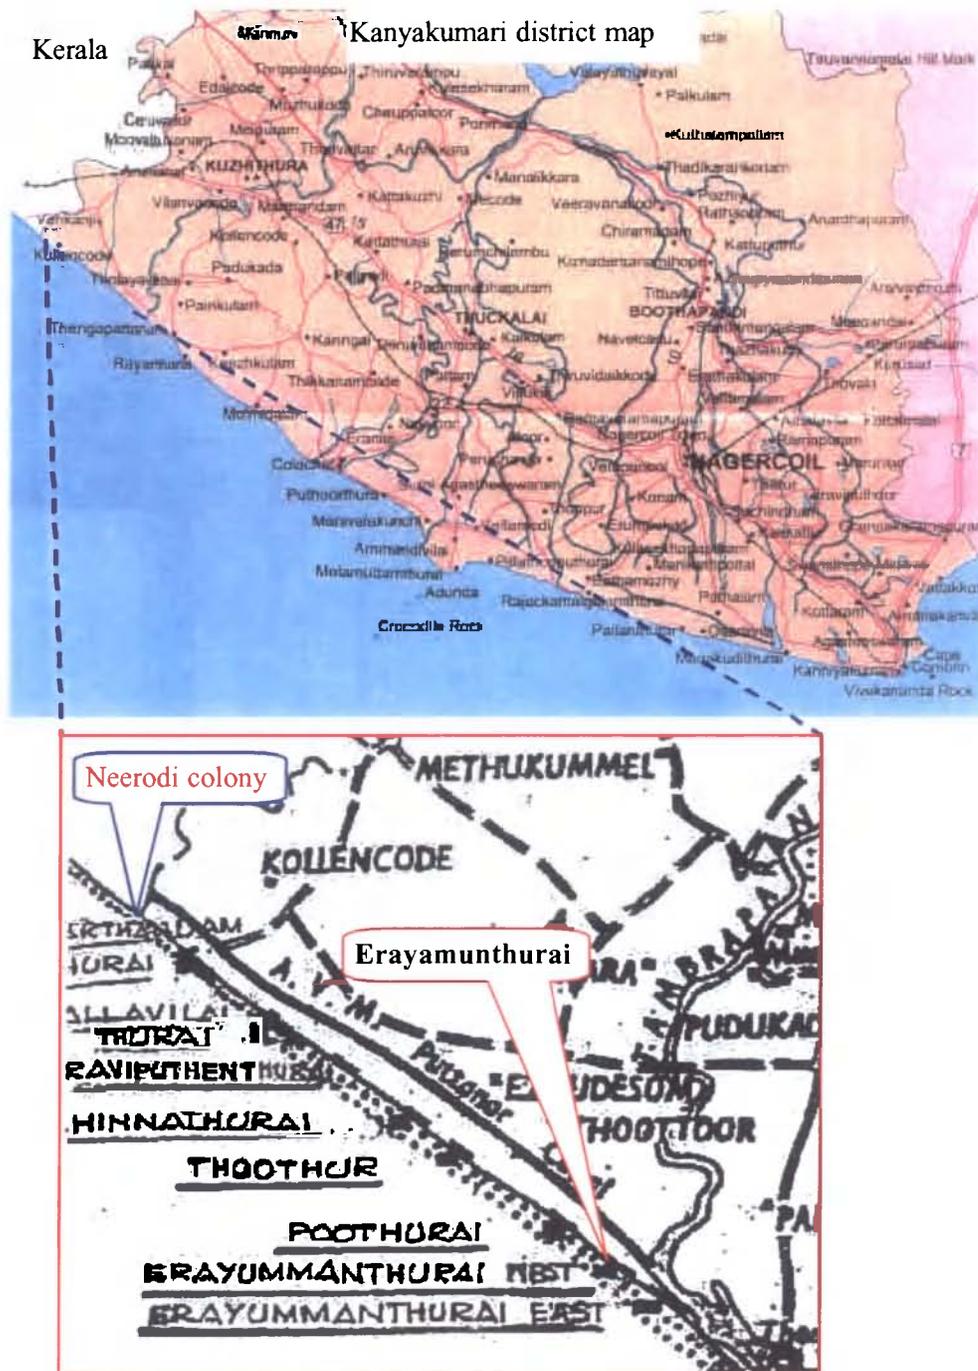
This stretch of the coast from Neerodi colony to Erayamunthurai, situated in the West coast of Tamilnadu state is shown in **fig. 3.2**. A number of dwelling units just close to the coast are facing threat of erosion. The width of the beach along this stretch of the coast is about 30 m as can be seen from the **photo 3.1**, gets washed away during the South-West (SW) monsoon leading to the entering of seawater occasionally into the dwelling units. It is observed that the beach slope in this stretch is quite steep. An existing sea wall for a length 1km is in a collapsing stage.

Fig.3.2 The stretch of the coast from Neerodi colony to Erayamunthurai

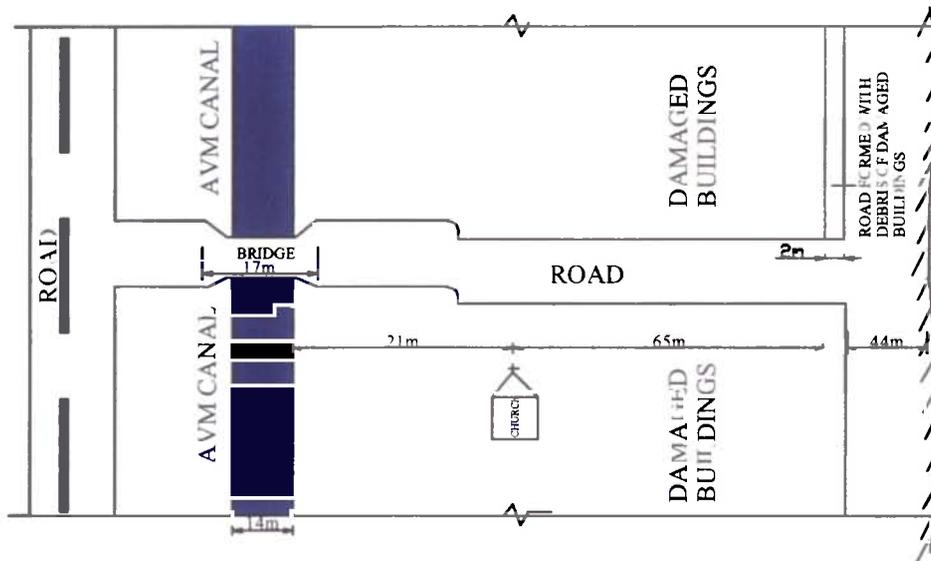
Fig.3.8 Plan of a damaged area Kottilpadu Colachel

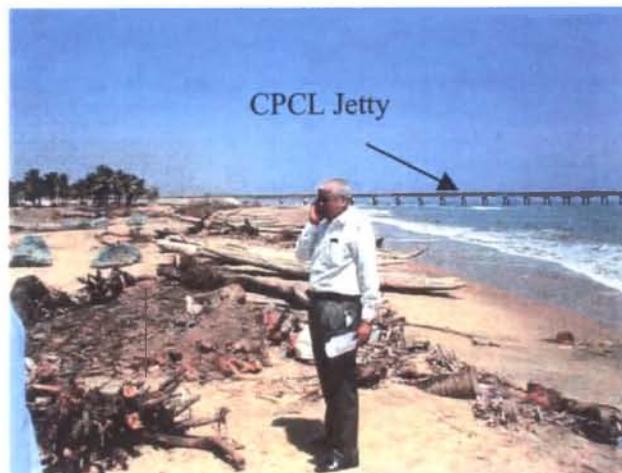
Photo 4.1 Damages to the property at Nagoor

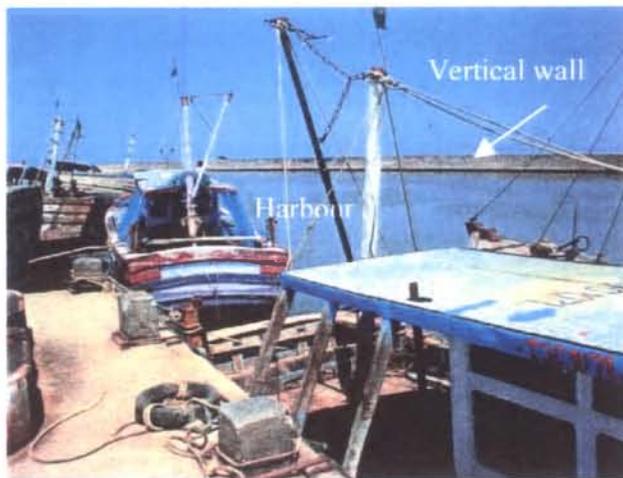
The barren land North of Nagapattinam port shown in **photo 4.5**, is an excellent place for dense plantations. The presence of the vertical wall (top level +2.7 m MSL) as shown in **photo 4.6**, constructed for the Nagapattinam port at a distance of about 60 m from the shoreline has acted as a barrier only marginally against the powerful tsunami. In spite of the presence of this wall, a number of boats were carried away to the land and water on its rear side has moved to a distance of 300 m and a height of about 8 m. The damaged boats behind the vertical wall are shown in **photo 4.7**, and the damaged portion of the vertical wall is shown in **photo 4.8**. The remedial measures are discussed in sec.4.1.2.

Photo 4.6 Presence of Vertical wall constructed at Nagapattinam

Implementation of Coastal Regulation Zone (CRZ) Act, now that the area is already been cleared, has to be enforced on top priority. Dense plantations as a long-term measure for a distance of about 9 Km is recommended (Nagoor to Keechankuppam) protecting about 6 villages with in this stretch of the coast. The recommendation is made for the two stretches namely, (between Kallar and Kaduvayar river mouths) and (Nagore to Kaduvayar river mouth). As littoral drift in this stretch is more towards the North and the coast is of sandy type, T – shaped groins would certainly trap the sediments and also retain the same with in them for the stretch between Kallar and Kaduvayar river mouths. In order to minimize the inundation of sea water into the land, a seawall is recommended. As the coast is just 0.6 m above MSL, a seawall is also recommended for the entire stretch of the coast. The details of the proposed layout for the stretch between the rivers Kaduvayaar and Kallar to protect the stretch of the coast in Keechankuppam are shown in fig. 4.2a & 4.2b. The average length of the groin

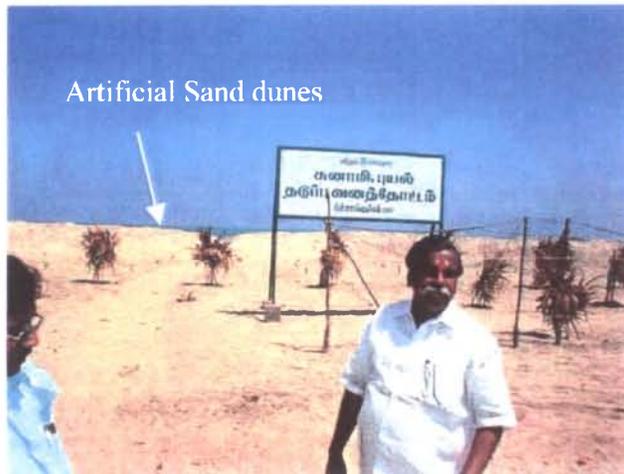
This is the worst affected area with in the stretch 'A' due to tsunami and a number of casualties and loss of property were reported. The plantations as shown in **photo 4.9** have just begun along the coast. The artificial sand dune at this stretch is shown in **photo 4.10**. It is to be stated that the plantations should be more dense compared to what has been done as of now. The tsunami has resulted in uprooting of several bridges and houses along this stretch (**Photos 4.11 a & b**). The remedial measures are discussed in sec.4.1.2.

Photo 4.9 The Coconut plantations planted post tsunami rear side of the sand dunes at Keechankuppam

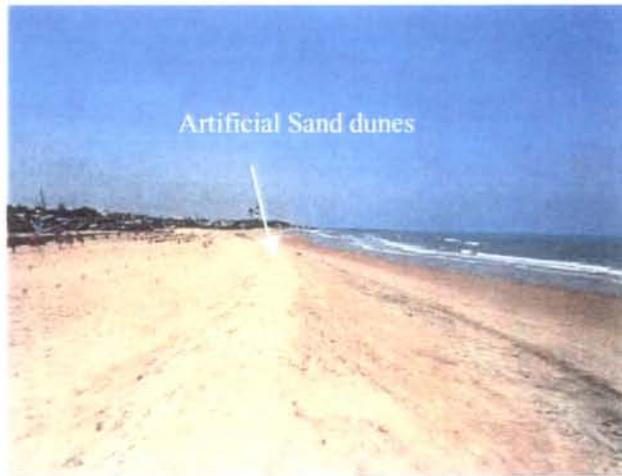
Photo 4.10 View of the beach and artificial sand dunes North of Keechankuppam

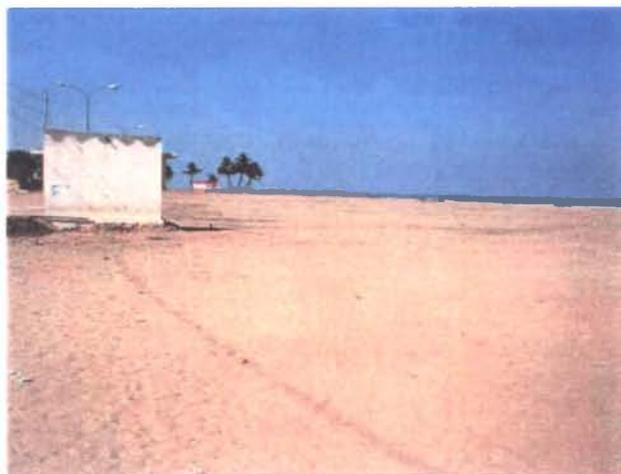
The damaged bridge connecting Nagapattinam and Kallar in the stretch 'B' is shown in photo 4.12. The hutments close to the beach have been washed away by the recent tsunami. A clear width of beach is available as can be seen in photo 4.13. The river Vellayar (photo 4.14) joins the sea adjacent to this stretch of the coast and is shown in the above photo. It is recommended to dredge the mouth of river Vellayar and nourish the beach on its Northern side as well as to construct a sand dune. Plantations backed up with sand dunes and masonry buffer blocks are recommended for this stretch of the coast as shown in the fig. 4.6. Both plan and sectional elevation of the proposed are shown in the above figure. The buffer blocks may also serve as a relaxing facility for the pilgrims and locals. After monitoring the shoreline for a period of about 2 years, a decision can be taken up on the necessity of a hard measure.

Photo 4.13. The flat beach North of Velankanni

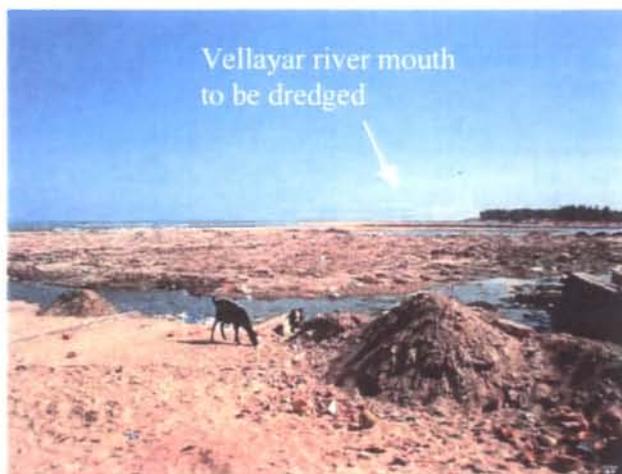
Photo 4.14. The confluence point of river Vellayar South of Velankanni

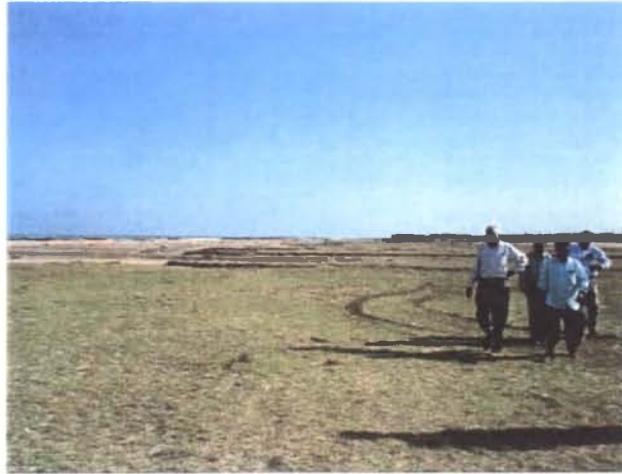
a distance of about 200 m. The shoreline is found to be stable and the beach south of this stretch is as shown in **photo 4.15**. Two long training walls for the improvement of the mouth of Nallar Straight cut should be taken up as shown in **fig 4.7**.

Photo 4.15. View showing beach South of Vellapallam

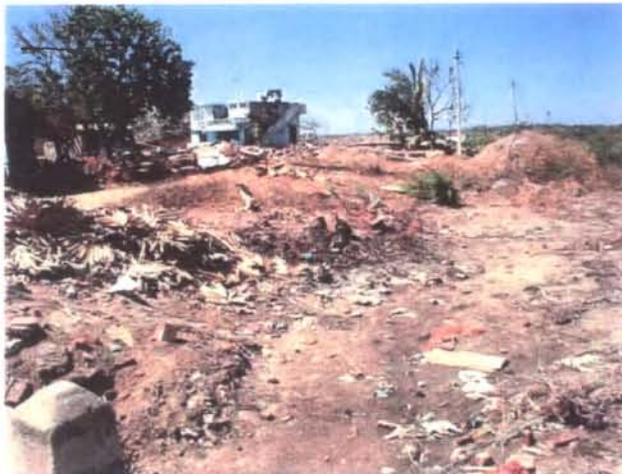
Photo 4.24. Damage to property North of Vaanagirikuppam

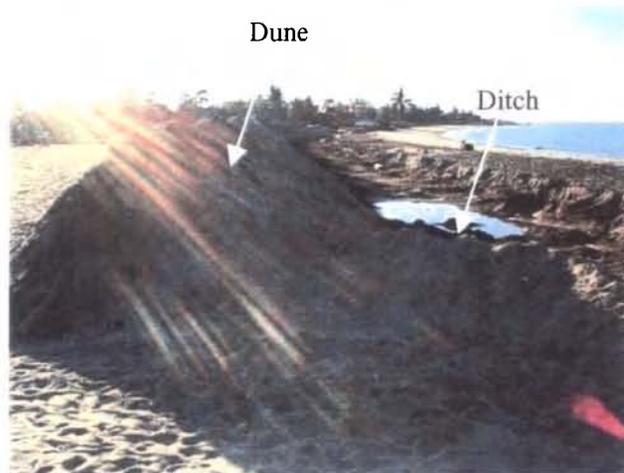
Photo 4.26. Typical damages to property due to tsunami at Palayur

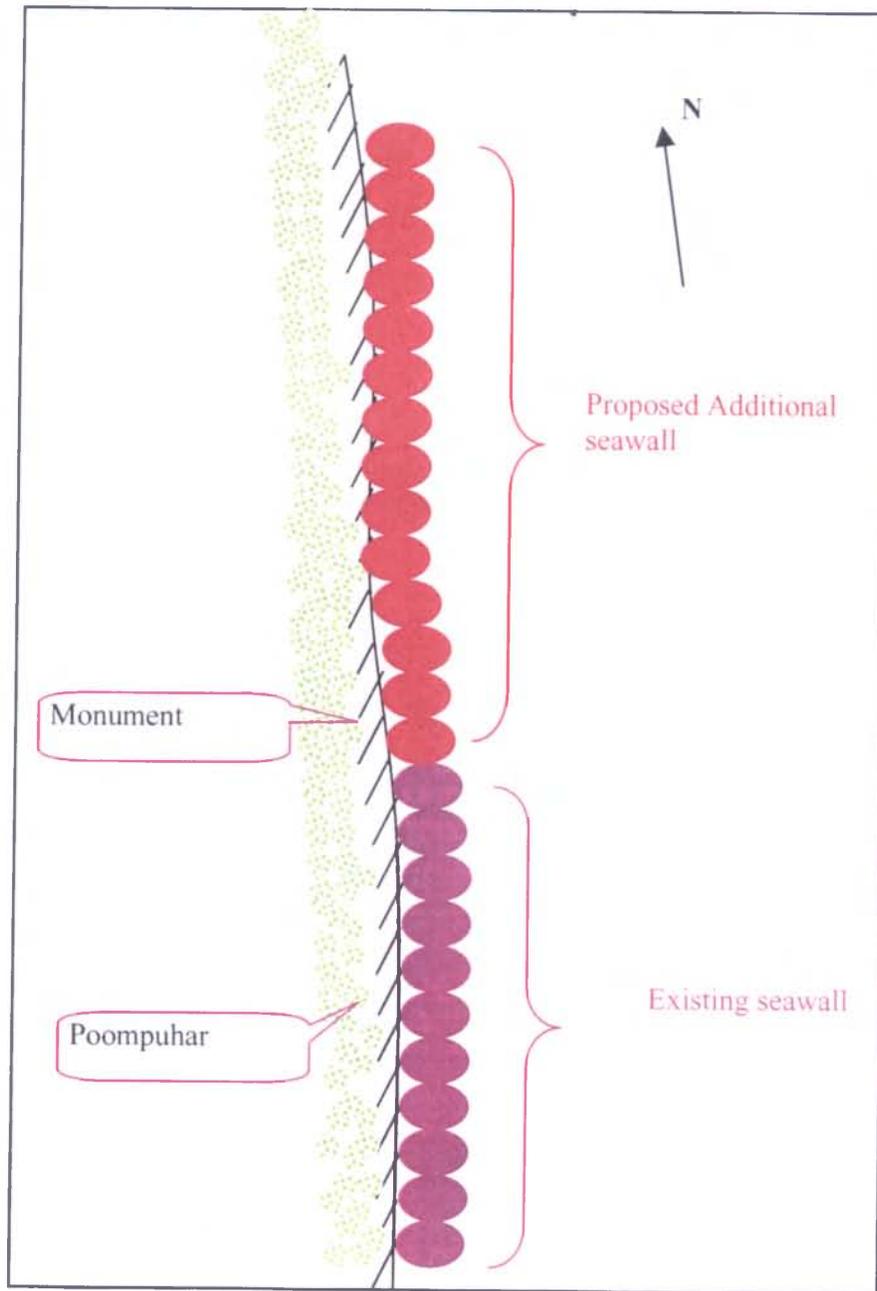
Fig. 4.11. Proposed additional seawall at Poompuhar

The beach south side of the above location protected by an existing seawall is shown in **photo 4.21**. The North side of this stretch is shown in **photo 4.22**. The tsunami has penetrated to a distance of about 75 m from shoreline with a run-up of about 1.5 m. The performance of the existing seawall is good as beach has formed. However, the seawall has to be rehabilitated with a crest elevation of + 4.3 m. The North of this village has to be protected by a seawall for a distance of about 650 m as shown in **fig. 4.11**. The large extent of barren land is to be developed with plantations.

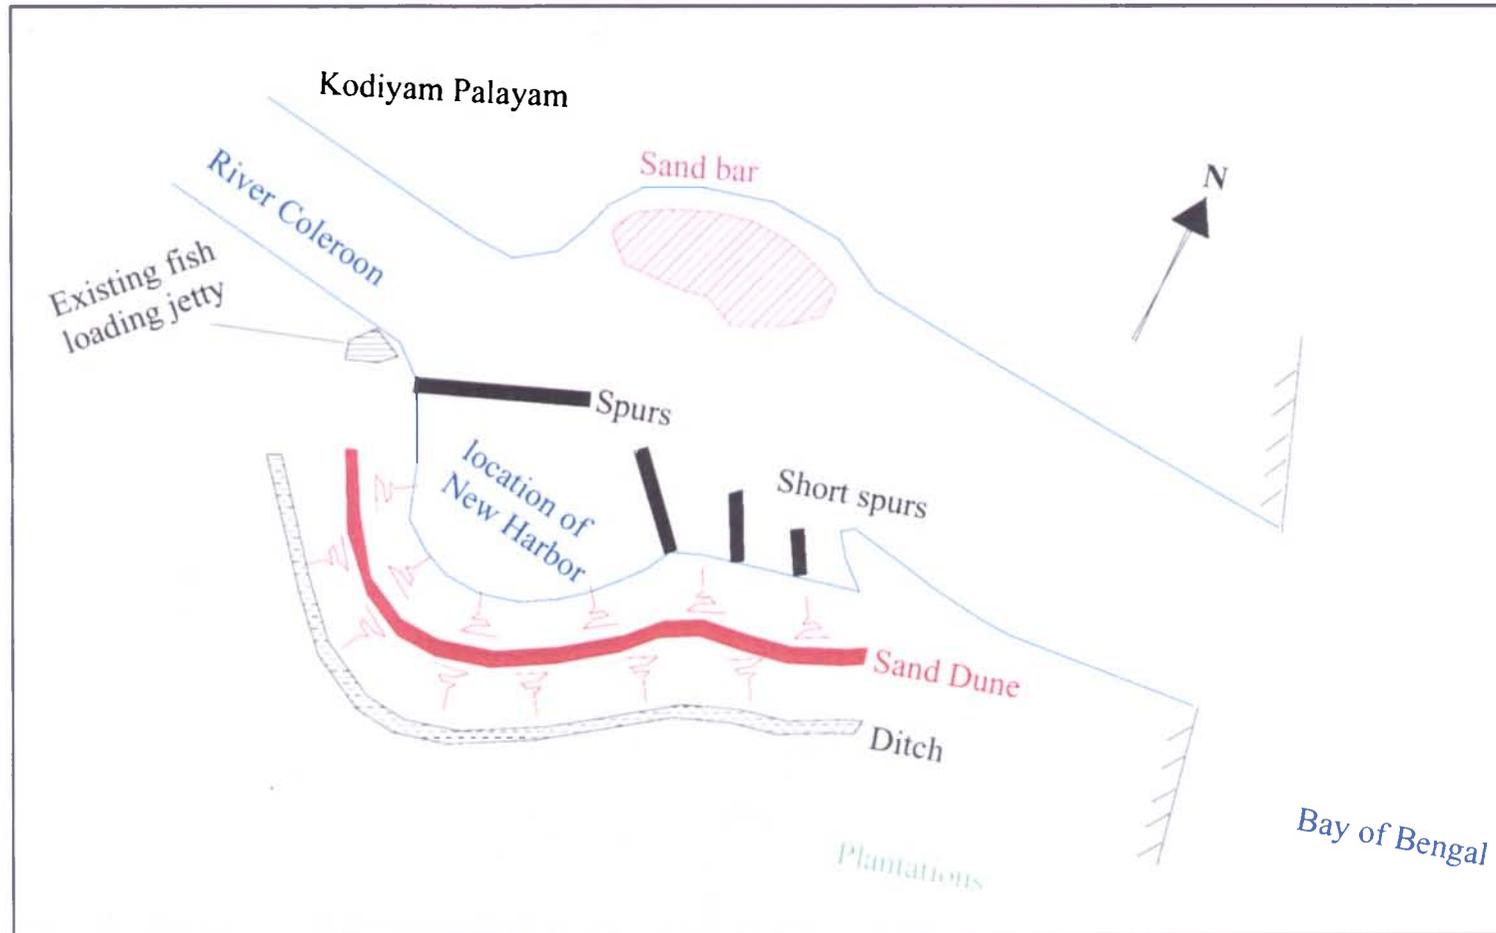
Fig. 4.13 Proposed Coastal protection measure at Palayur

Geo-tubes with its top level of + 6.0 m above MSL. For this purpose, the shallow regions can be dredged and the dredged spoil can be used for the creation of the dune. The wide mouth of the river Cooleron is shown in photo 4.28. A portion of the bank can also be planned for landing jetty in future after the protection of the river bank with spurs. The details of the proposed scheme are shown in fig. 4.13.
